Power Plant in Thailand Uses CeramAlloy[®] and CHEMCLAD[®] to Repair and Protect Cooling Water Pipeline

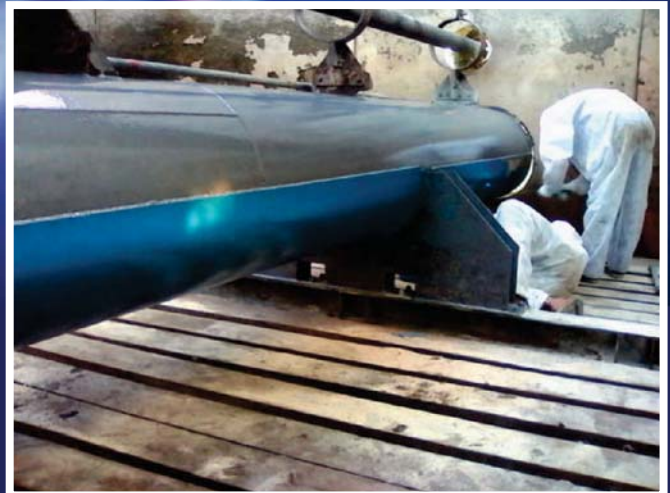
This cooling water pipeline at a power plant in northern Thailand is subject to severe erosion and corrosion due to water forced out by the fans located on top of the pipes as seen in the bottom left photograph.

The bottom half of the pipe (only 2 mm / .08 inches thick in some areas) was repaired using welded plates which were bonded to the pipe with CeramAlloy[®] CP+AC followed by two layers of CeramAlloy CL+AC.

The top of the pipe was coated with CHEMCLAD[®] SC as a cost saving measure.
