Power Station Brings Salt Water Circulating Pump Back to Life

This utility in the northeastern U.S. reclaimed a damaged salt water circulating pump using METALCLAD CeramAlloy and some outstanding repair techniques.

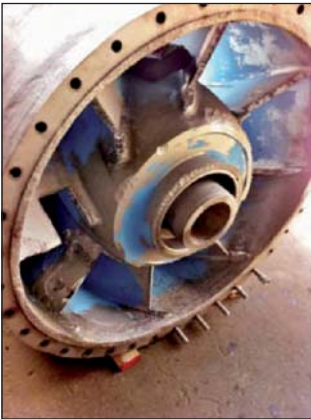
The severely eroded vanes were cut away.

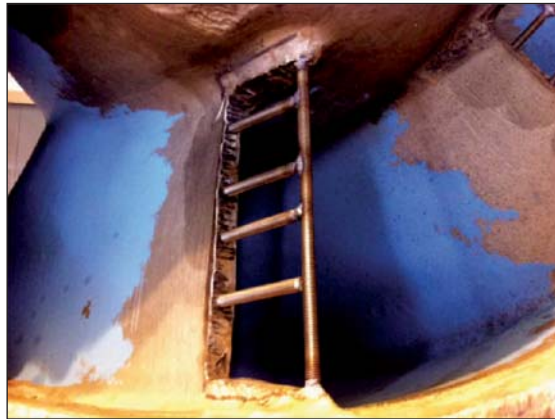
A threaded rod "skeleton" was installed by tack welding to the already cut vanes.

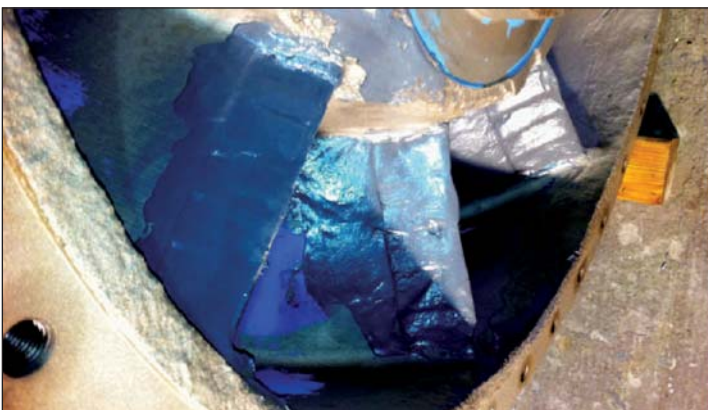
CeramAlloy CP+AC used to rebuild the vanes to their original size.

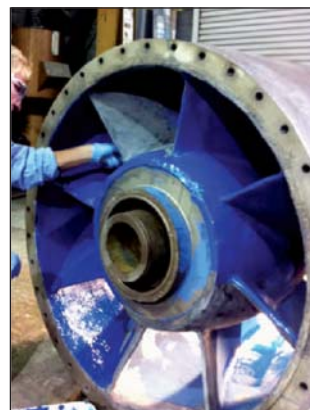
CeramAlloy CL+AC used to coat all surfaces.

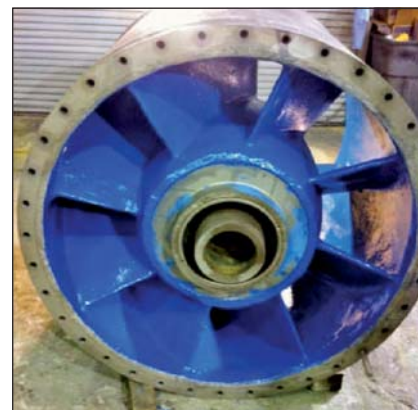
The completed component ready for service.
