## Chilean Hospital Pumps Brought 'Back to Life' with CeramAlloy<sup>®</sup> and CHEMCLAD<sup>®</sup>

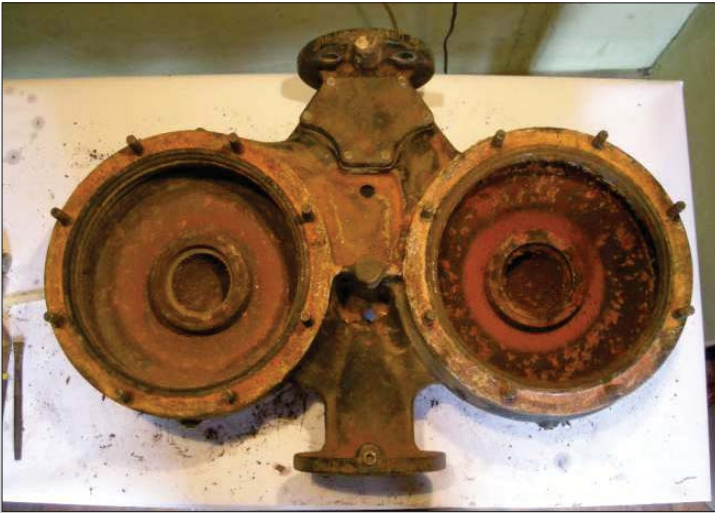
This hard water pump at a hospital in Chile was only averaging a few months in service before maintenance would have to be performed to repair deep erosion / corrosion damage.

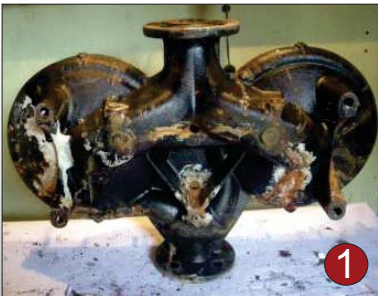
1. The pump casing before being refurbished.

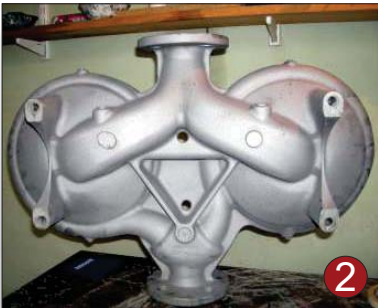
2. The pump casing after grit blasting.

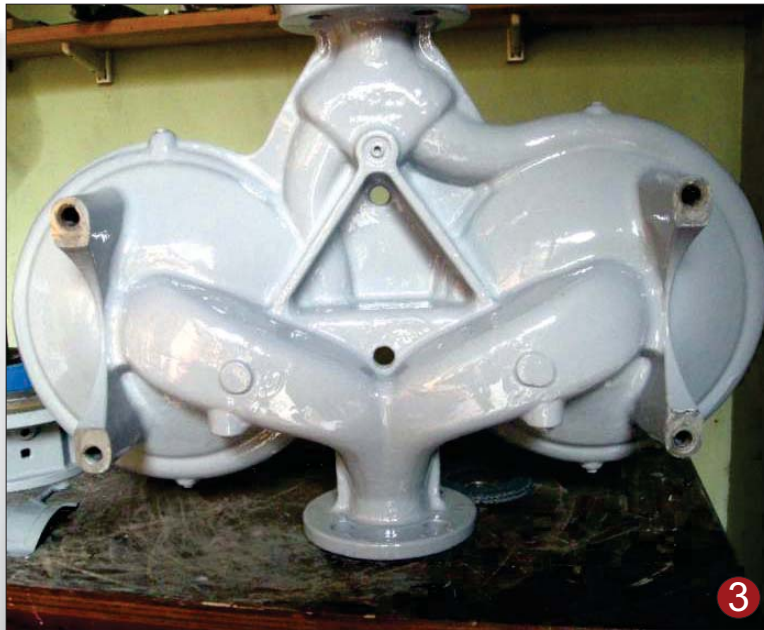
3. The pump casing was coated with CHEMCLAD SC which protects from future erosion / corrosion.
