60 Year Old Pump Casings Are Saved By DuraWrap

A major power station in Bavaria had a serious issue with these two 60 year old pump casings. They were in very poor condition – structurally compromised and leaking.

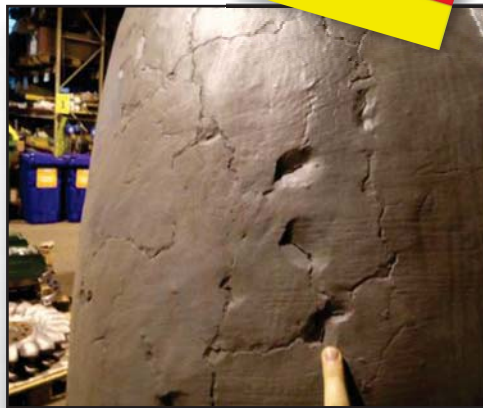
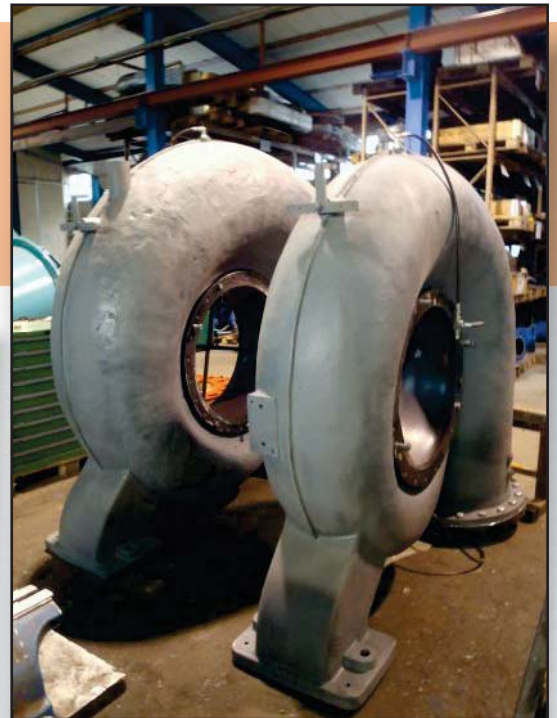
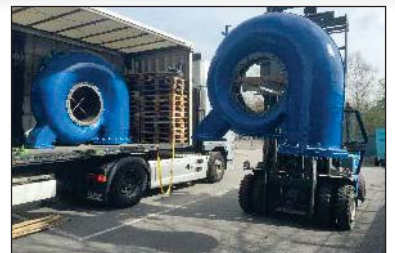
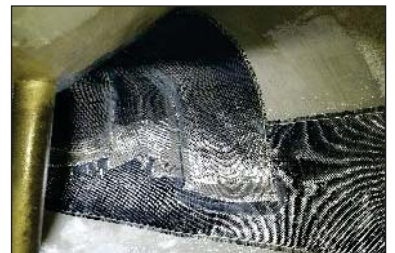
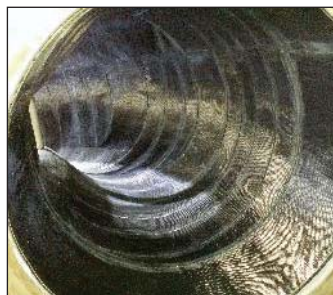
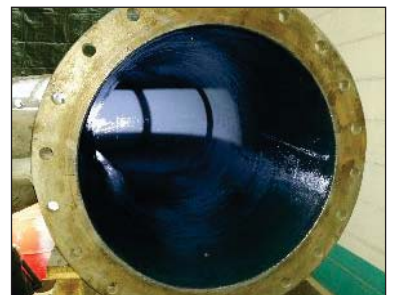
ENECON Germany were called in to see if they could refurbish these casings which weighed about 2 tons each. The power station engineers were worried that due to metal fatigue, the casings would no longer be able to withstand the operating pressures and, at some point, they could fail causing catastrophic damage to the turbine.

The casings were grit-blasted and then *METALCAD DurAlloy* was used to seal the leaks and rebuild all the metal back to the original thickness, shape and contour.

The *METLACLAD DuraWrap* system was then applied on the *interior* of the pump casings in order to reinforce and restore their structural integrity.

CHEMCLAD XC was applied over the *DuraWrap* to provide a smooth surface finish in order to restore/improve the components' pumping efficiency.
