## CeramAlloy Solves Erosion & Corrosion Problems on Panama Canal Tugboat Pump

At the Panama Canal, a fleet of tugboats assists ships passing through the newly expanded locks. Each of the tugboats have pumps like this one, which pump salt water.

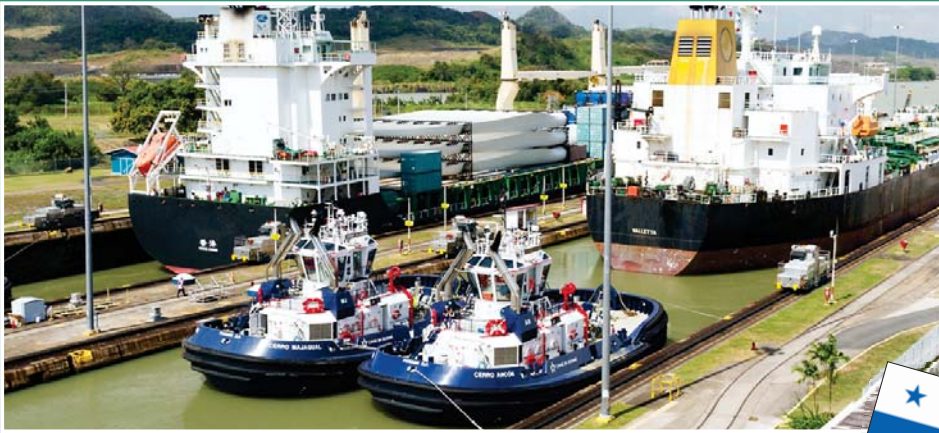
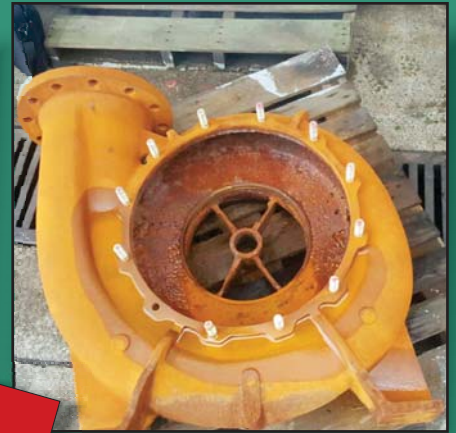
Constant exposure to salt water caused the entire surface of this pump to suffer from erosion and corrosion. This caused a weakening of the metal which then reduced the pump's efficiency in addition to leaks at the seams.

After grit blasting the pump and all of its components, a first coat of CeramAlloy CL+AC was applied to wet out all surfaces. CeramAlloy CP+AC was then used to rebuild the weakened and damaged areas. Then a final layer of CeramAlloy CL+AC was used to protect the pump from future erosion and corrosion problems.
