## Francis Turbine Wicket Gates Repaired & Protected With CeramAlloy

### Francis Turbine

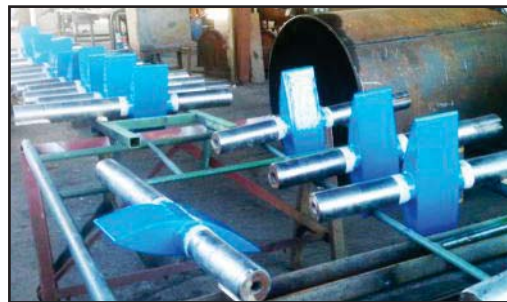
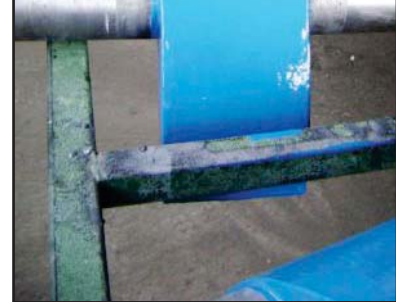
This Chilean hydroelectric company is pleased with not only the results, but the time and money that they have saved which is in the hundreds of thousands of dollars and counting. They are now using CeramAlloy to repair and protect pump casings, impellers, valves, etc. from severe erosion / corrosion. Now these components are longer lasting and *better than NEW!*

It was decided to prepare the surfaces by grit blasting to remove all of the fatigued and corroded metal. CeramAlloy CP+AC was then used to rebuild the gates. CeramAlloy CL+AC, in gray, was applied as a first coat followed by CeramAlloy CL+AC, in blue, as the second and final coat.
