CeramAlloy Used To Repair & Protect 35 Year Old Chiller

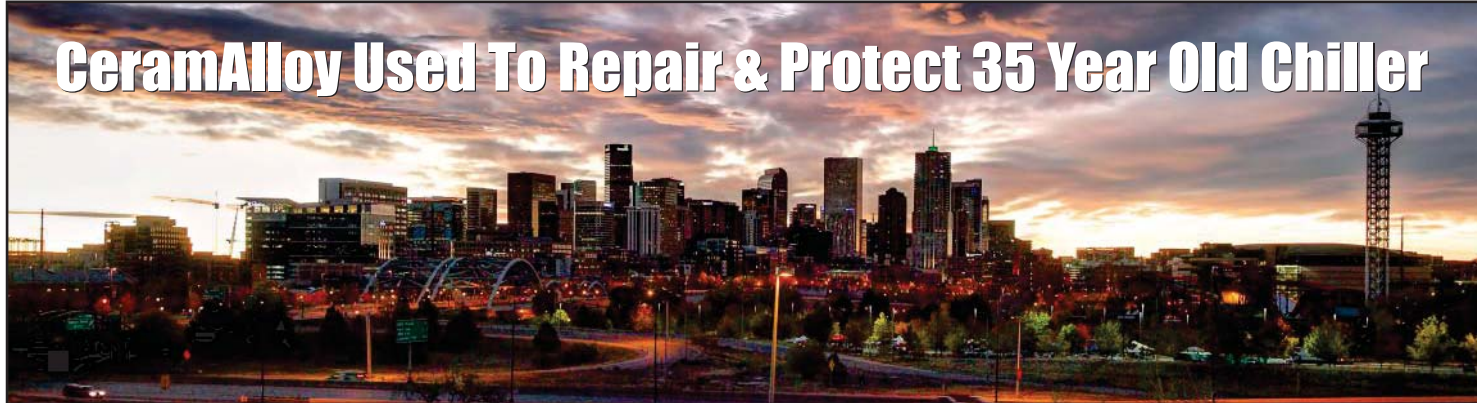
A Denver office building was dealing with a large, 35 year old chiller that had begun to leak around the gasket. Upon inspection it was discovered that there were several causes of the leak.

Years of use of a daisy style gasket had exposed sections of the flange face to erosion and corrosion. The inside face of the box near the flange was eroded as well as a groove worn into the end cap.

the damaged areas. Two coats of CeramAlloy CL+AC were then applied to protect these components from future erosion / corrosion damage.

ENECON was able to bring this huge 18 foot long, 35 year old unit back into service and deliver a solution designed to give them many years of additional service.

After grit blasting, *METALCLAD CeramAlloy CP+AC* was used to rebuild
