## Industrial Manufacturer Specifies METALCLAD & FLEXICLAD For New & Used Blower Casings

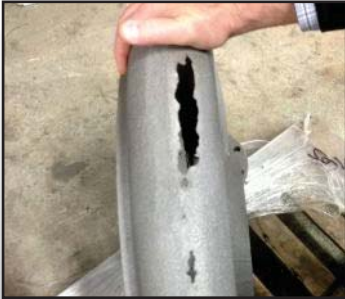
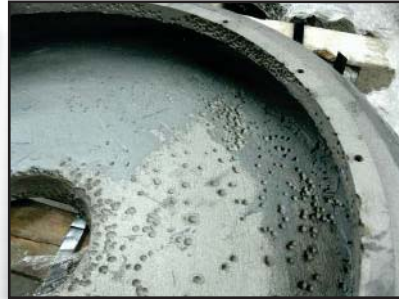
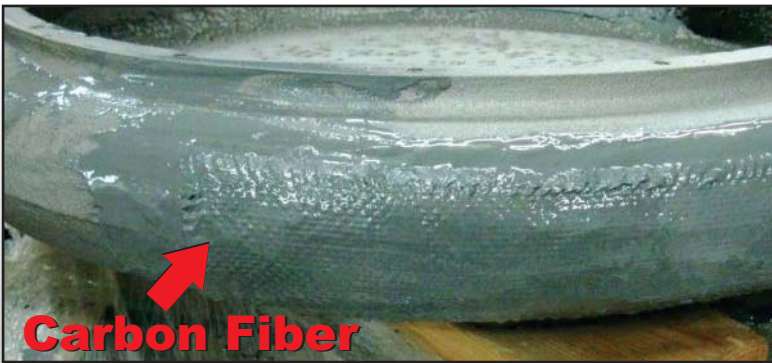
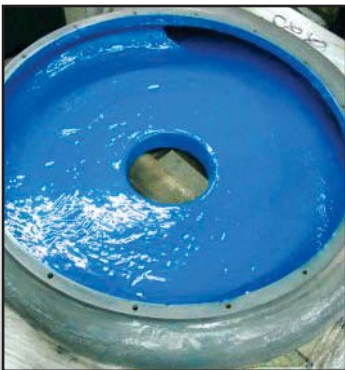
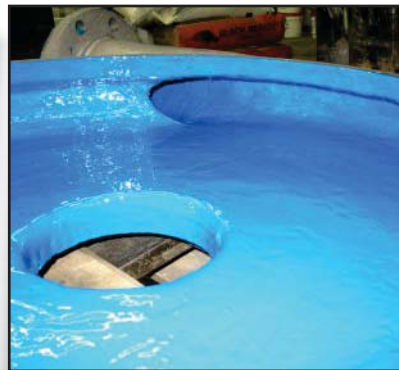
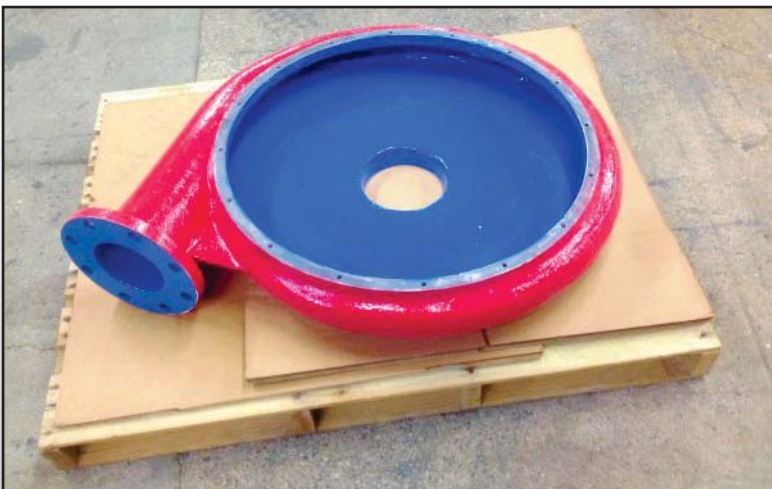
An industrial cable manufacturer was replacing their eroded and worn blower casings every six months because of the fine particulate circulating in the air passing through them. The plant's maintenance management was in need of a more cost effective solution.

DurAlloy was used to rebuild the severely worn and pitted areas. Carbon fiber was used to bridge the gap in the areas where there was complete metal loss. Two coats of CeramAlloy CL+AC were applied followed by a top coat of DuraTough DL, to provide added erosion resistance to the interior blower surface against the circulating particulate.
