Outdoor Fountain At Pennsylvania Landmark Building Is Repaired With CeramAlloy CL+AC

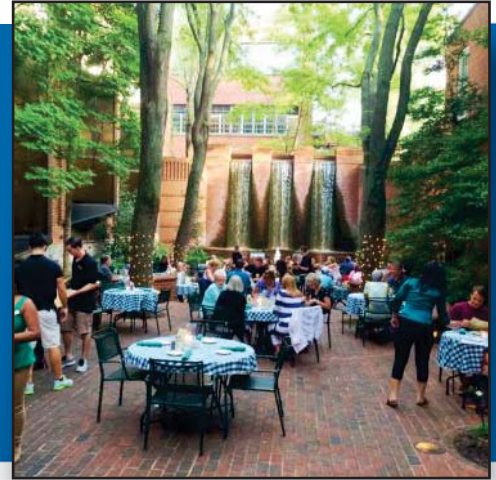
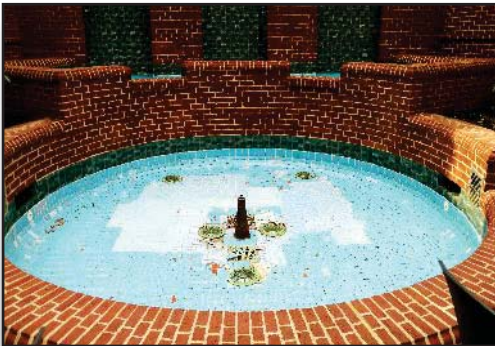
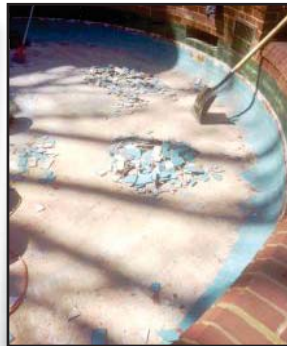
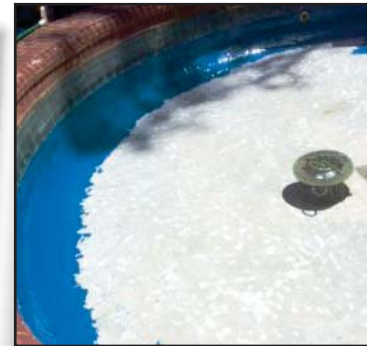
This fountain, located in the outdoor dining area of a restaurant, was in need of serious repair. The fountain's tiles were coming loose and very difficult to color match and replace. The replaced tiles wouldn't hold in place very long either.

The fountain was drained of its water and all of the tiles were removed. The concrete surface was manually prepared with a grinding wheel. Two

coats of CeramAlloy CL+AC were then applied to provide fluid flow erosion and corrosion resistance.

This project was completed in just four days with little disruption to the restaurant. The maintenance team was thrilled with the results and have reported that management receives compliments from the restaurant diners almost daily.
