After 14 years In Service, CeramAlloy Is In Perfect Condition At Steel Mill

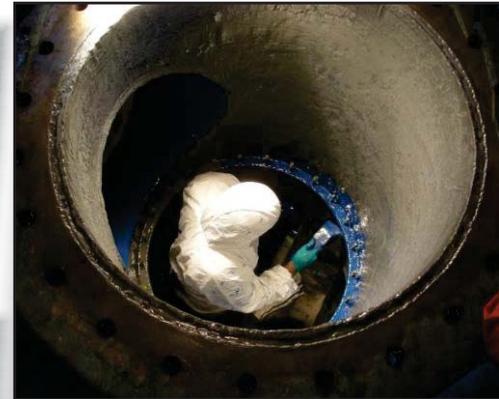
After 5 years

Approximately 5 years later, the strainer was inspected to monitor the condition of the repair. As shown in photo 1, below, the blue *CL+AC* was showing no signs of deterioration and was performing perfectly under the dirt residue.

The first stage in surface preparation was to abrasive blast the strainer in order to remove all the failed coatings and corrosion. The steel was then washed down and left over night to enable impurities to leach out. After re-blasting, *CP+AC* (ceramic paste) was applied to fill the extensive corrosion

pitting. While the *CP+AC* was still tacky, a layer of *CL+AC* (ceramic liquid) was applied to provide the highest degree of erosion and corrosion protection.

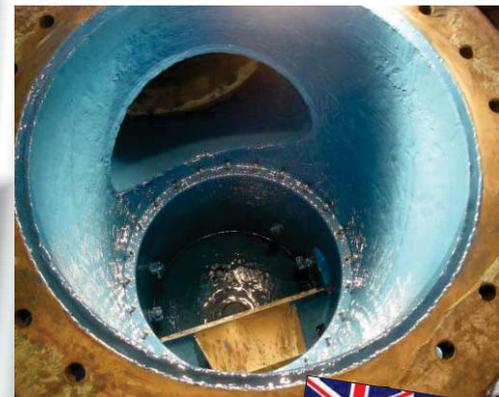
After 14 years

Nearly 14 years after the initial project, the strainer was inspected again.

Once again the *CeramAlloy* was still in original condition under the recycled water residue shown in photo 2. Even maintaining its original gloss after being wiped down with a small amount of bottled water.
