Broken Curbs In Montana Are Repaired & Protected With DuraFill, DuraQuartz, FLEXICLAD PC & ENESEAL CR

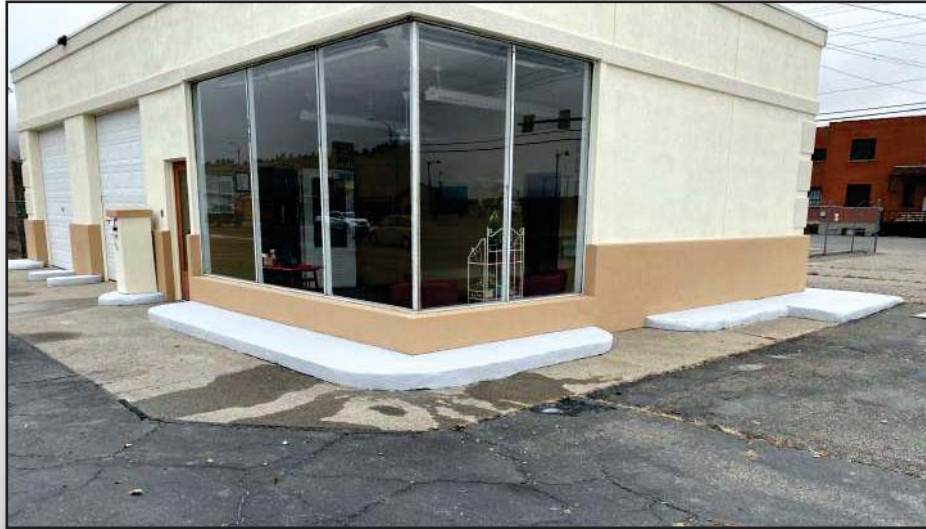
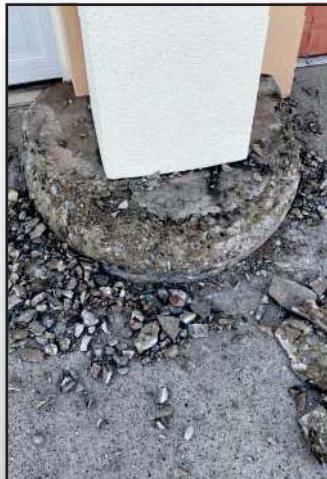
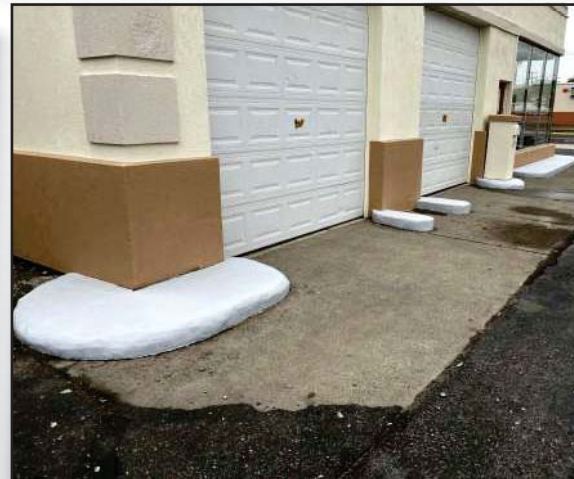
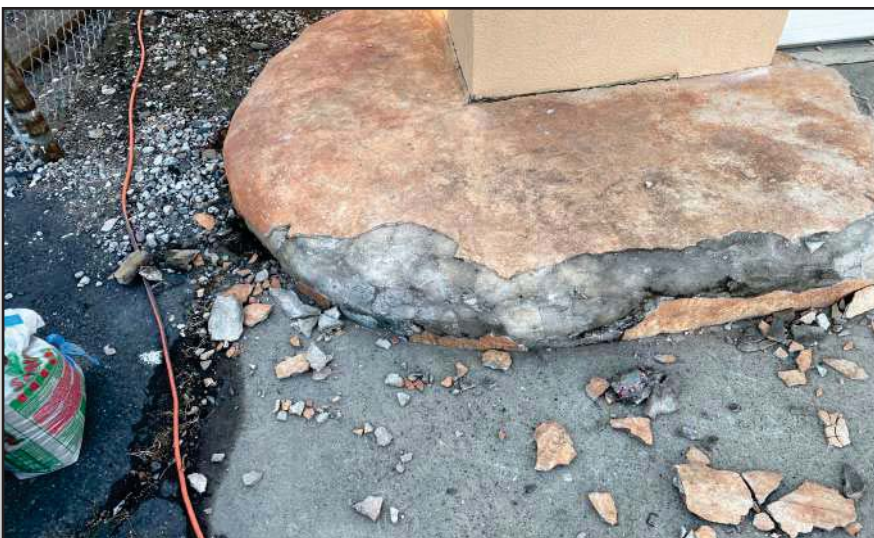
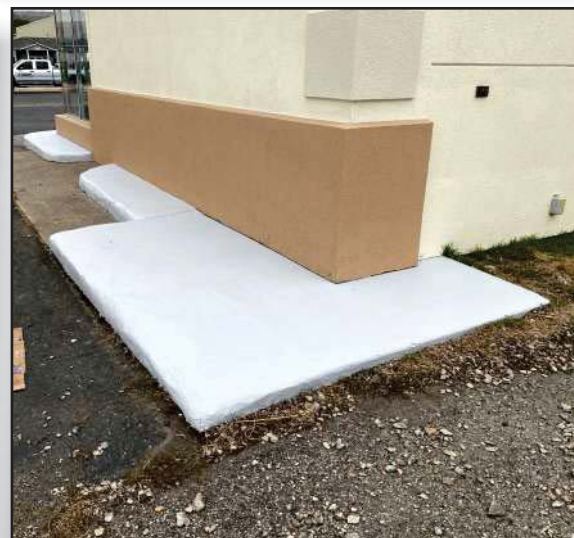
Damaged concrete curbs outside of a small Montana business were cracked and crumbling after years of expansion and contraction from freeze/thaw cycles. The local ENECON Distributor was called in to provide a solution.

After removing the loose material and cleaning the areas, the curbs were repaired with ENECRETE DuraFill & DuraQuartz. All of the curb/building joints were filled with FLEXICLAD PC to allow for expansion. A final overcoat of ENESEAL CR was used to provide an attractive appearance.
