Canadian Hospital Uses DuraQuartz To Repair Hallway Floor Seam Joint

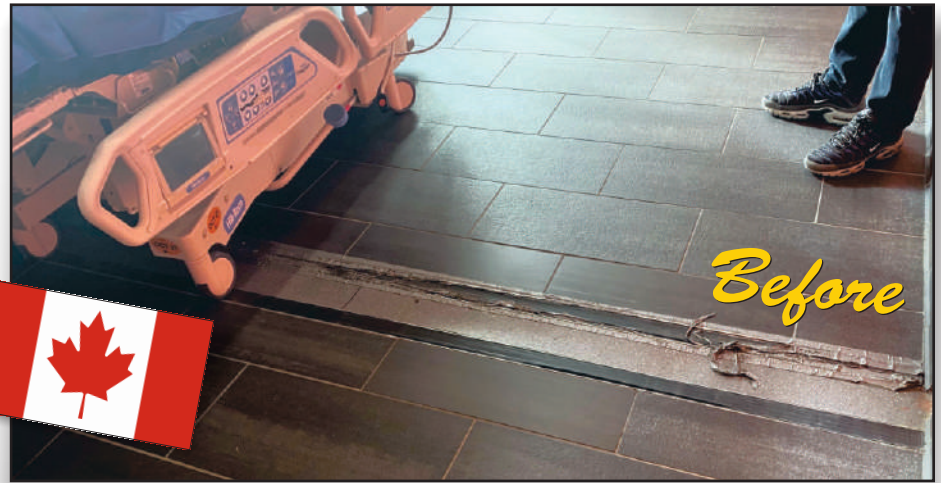
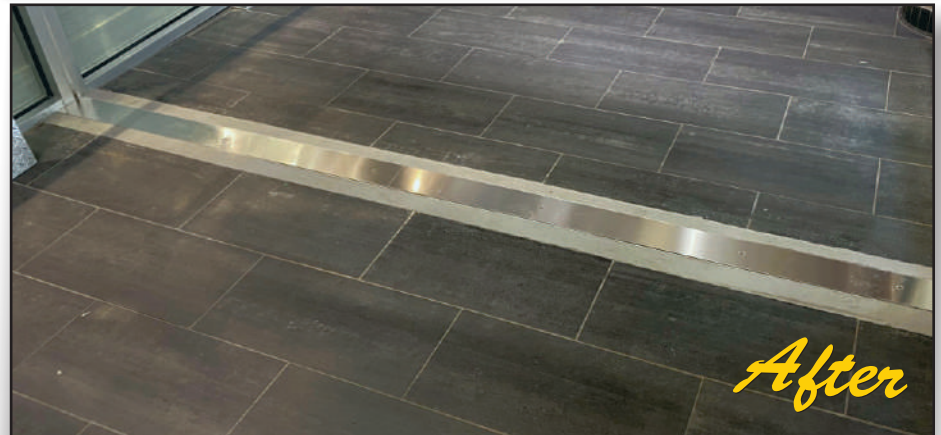
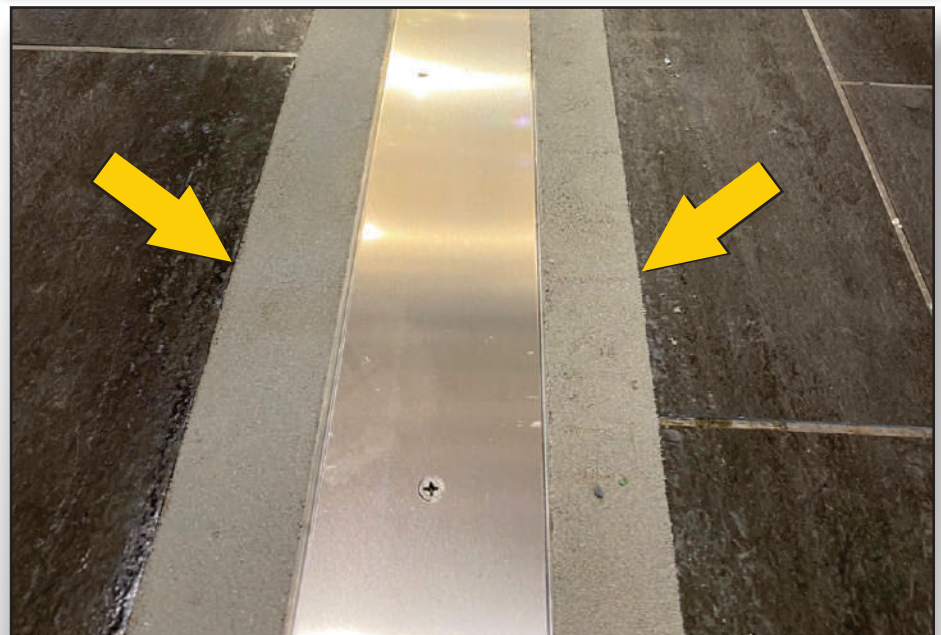
This floor expansion joint in one of the major hospitals in Montreal, Canada, needed to be replaced. Its condition was worsening every day because of constant traffic in the hospital hallway. The hospital had to temporarily fix and then re-fix the joint almost every other day, with duct tape. This was creating a tripping hazard for patients and hospital staff.

An airtight enclosure with a HEPA filter was constructed around the area to contain any dust. The old joint was removed and the area was manually prepared and cleaned.

ENECRETE DuraQuartz was used to build back the joint sections and an aluminum floor expansion joint cover was set on to the DuraQuartz.

This work took two nights to finish. During the day a small aluminum bridge was constructed by the application team to protect the joint from the regular daily hallway traffic.
