ENECON® NEWS

MT-180

Aluminum Can Manufacturer Protects Gray Water Tank With CeramAlloy

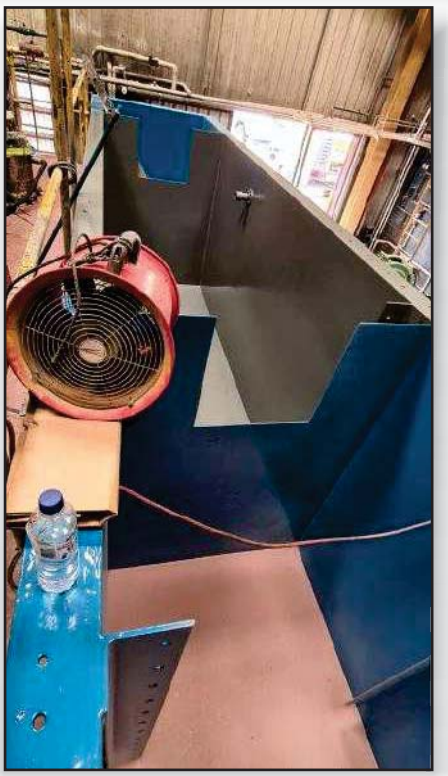
In this steel tank, 98% sulphuric acid and sodium hydroxide are mixed with the manufacturing byproduct gray water to neutralize the content of the water. The existing rubber liner was corroding and had holes, creating leaks in the tank.

The rubber liner was high pressure water blasted off the inner tank surface. The inner surface was then abrasive blasted followed by a thorough cleaning. Two coats of CeramAlloy CL+AC were applied to provide corrosion protection. Not only did this application save this manufacturer the cost of a new tank, the downtime was limited to only 5 days.
