ENECON® NEWS

MT-161

After 4+ Years Of Service In An Alumina Refinery, CeramAlloy CBX Is Still In Excellent Condition

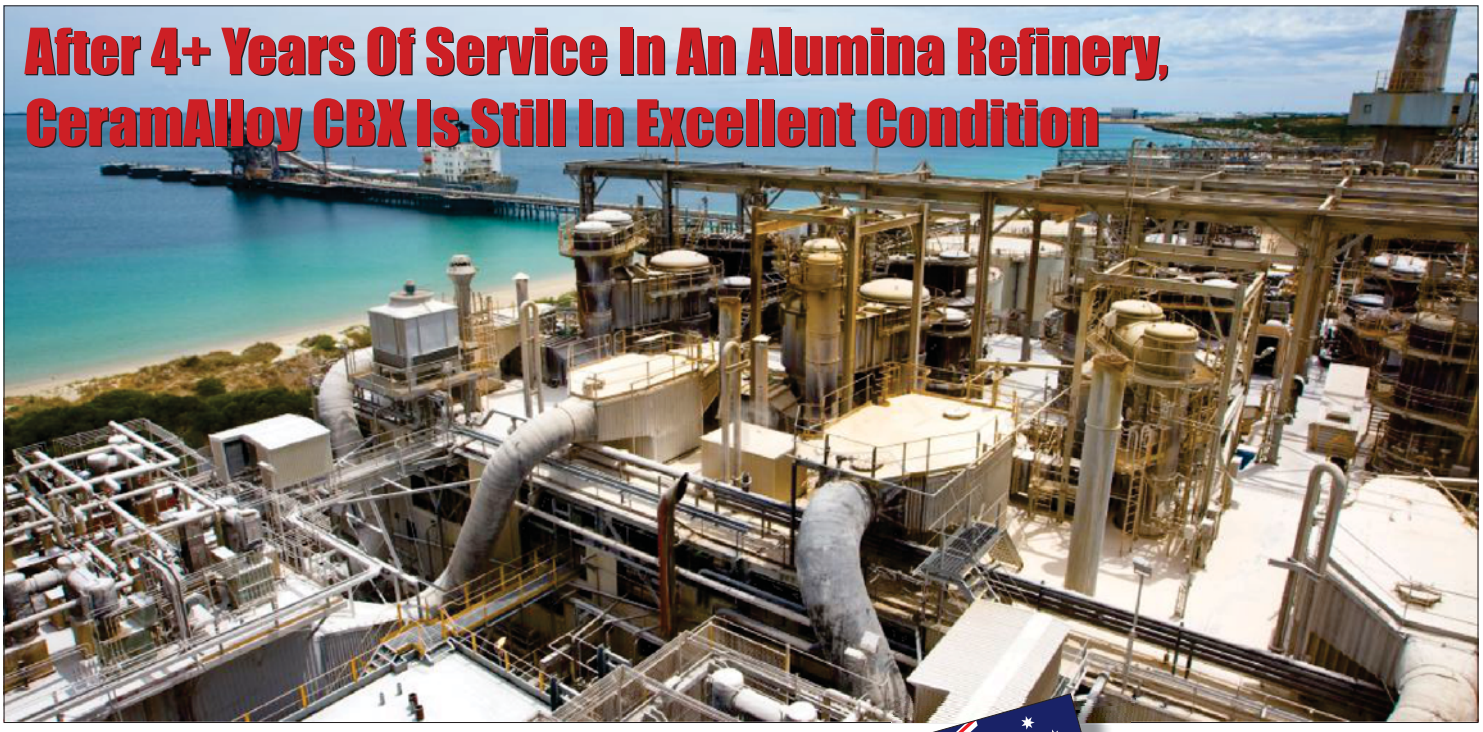
Calciner screws, subjected to extreme abrasion typically only last 12-18 months.

This screw (image 1) was protected with CeramAlloy CBX and put back into service for over 4 years.

After brush blasting clean, the CeramAlloy CBX is shown to still be in excellent condition (image 2).

After 4+ years in service.

After cleaning, the CBX is still in excellent condition.
