ENECON® NEWS

MT-172

DurAlloy, CeramAlloy, & Carbon Fiber Repair Dredge Ship's Spool Piece

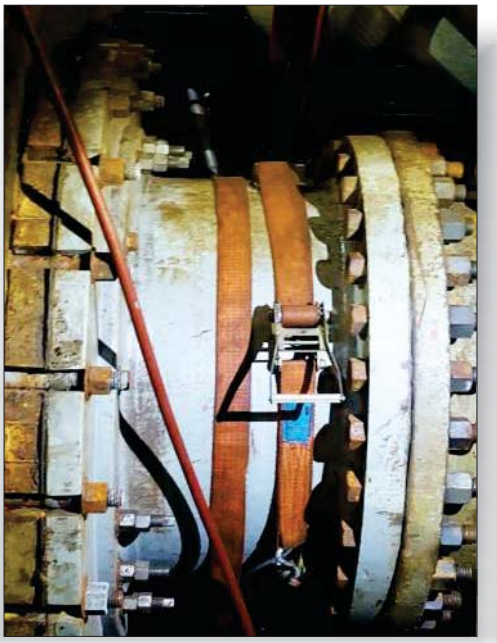
The spool piece in the image below was a fabricated replacement piece for a hopper dredge. During the installation and testing of the spool piece several pinholes were found.

The area with the pinholes was first vacuum blasted and the holes were repaired with DurAlloy. CeramAlloy CP+AC was then applied followed by a layer of carbon fiber wrap.

A second layer of CeramAlloy CP+AC was applied. CeramAlloy CL+AC was applied as a final topcoat to encapsulate the entire repair.
