CH-092

Russian Chemical Processing Facility Repairs Containment Area With ENECLAD, ENECRETE & CHEMCLAD

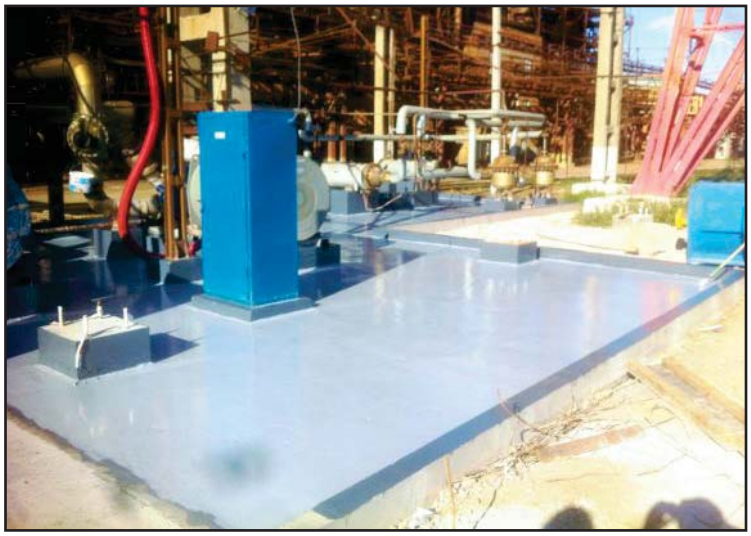
Problem: *Concrete in secondary containment areas for ammonia and sodium hydroxide storage tanks were deteriorating from corrosion due to exposure to these chemicals. The area spanned over 6,500 sq ft and the facility needed a cost effective, durable solution.*

Solution: *After preparing the area, all the missing concrete, cracks and holes were repaired with ENECRETE DuraQuartz. The entire area was then coated with ENECLAD CFS (Clear Floor Sealer). Finally, 2 coats of CHEMCLAD SC were applied to provide the chemical resistance this area was in need of.*
