ENECON® NEWS

CH-096

Theme Park Repairs & Protects Concrete Floor With ENECRETE & CHEMCLAD

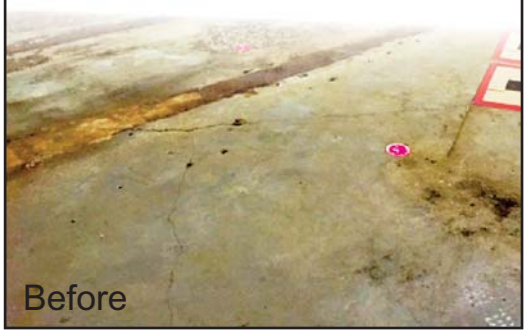
A trash compactor room inside a major theme park in Hollywood - Los Angeles, CA, was suffering from severely corroded and pitted concrete floors. These issues were causing slip, trip and fall concerns for the park's maintenance staff. It was also allowing trash residue to seep into the pores of the concrete, creating an unpleasant odor in the area.

After researching many options, including full concrete replacement, the park maintenance team chose ENECON's *ENECRETE DuraQuartz* to repair the damaged concrete. The concrete was primed with CHEMCLAD P4C, followed by two coats of CHEMCLAD SC. One coat back rolled with silica sand to provide slip resistance, and then the top coat for protection.
