## FLEXICLAD Repairs Cavitated Pump in Puerto Rico

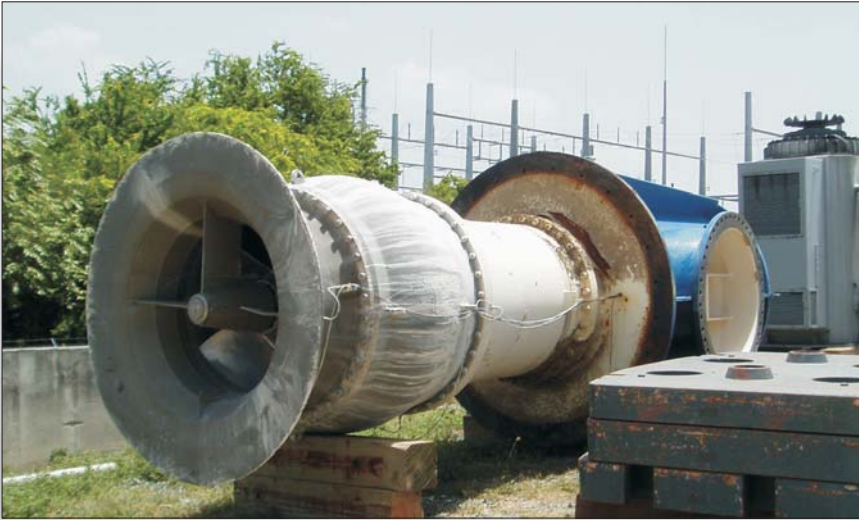
The stainless steel impeller of this large pump, located at a waste water treatment facility in Puerto Rico, was suffering from severe cavitation. The facility engineers needed a fast, reliable as well as cost-effective repair. The local ENECON Distributor was contacted to help find a solution.

It was decided that the impeller would first be prepared by grit blasting, followed by all cavitated areas being rebuilt with **DuraTough DP**.

The impeller was then protected from future cavitation damage with **DuraTough DL**.

In addition, **CeramAlloy CL+AC** was also used to protect the impeller's edges. **CeramAlloy CP+AC** and **CL+AC** were also used to rebuild and protect the pump casing which had significant corrosion damage.
