## South Florida Municipality Salvages "Hopeless" Pump Impeller with DurAlloy & CeramAlloy for Less Than Half of What a New Impeller Would Have Cost.

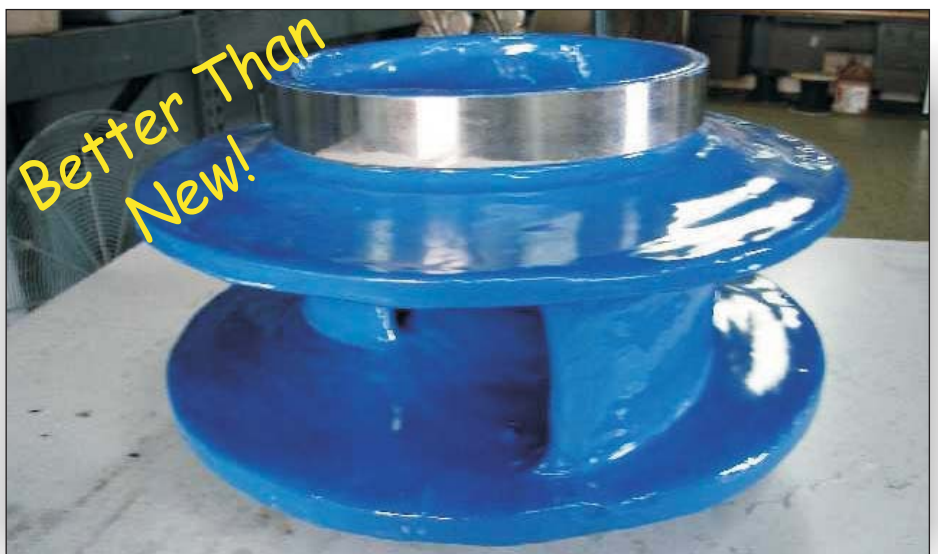
The original size of the impeller was 295 millimeters. The damaged impeller was only 281 millimeters! Not only was the impeller very worn, but

the top and bottom flanges were out of round and uneven, as well. Because of its machinability, DurAlloy was first used to rebuild all the damaged areas back to original shape and contour.

Two coats of CeramAlloy CL+AC were then applied to completely resurface and protect the impeller and improve the pump's overall efficiency.
