Oil Company in Thailand Repairs 22 'Problem Areas' with DuraWrap

Client: Major oil company

Location: Thailand

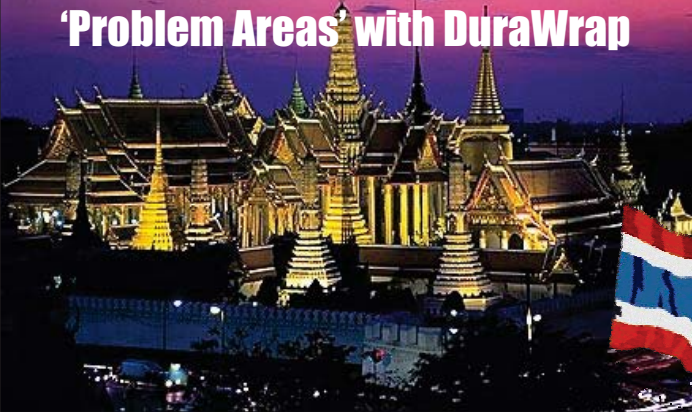
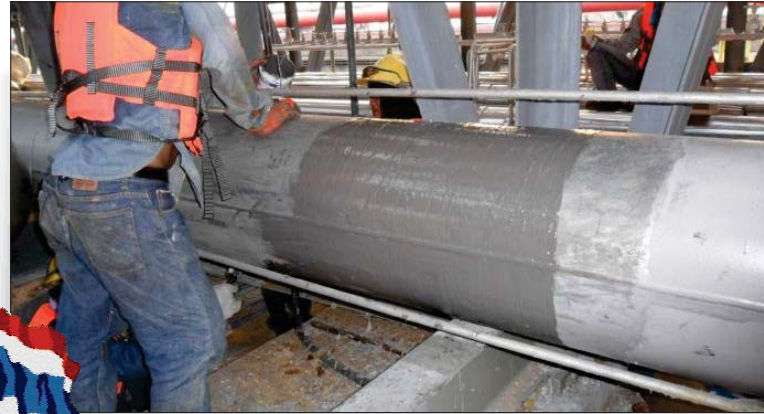
Problem: 20" diameter pipe was severely rusting in 22 different locations.

Solution: Original galvanized coating was removed. Rusted areas were manually prepared by grinding and wire brushing. *DurAlloy* was used to repair any damaged areas on the pipe. *DuraWrap Primer* was applied followed by two layers of *DuraWrap Carbon Fiber System*.
