DurAlloy & CHEMCLAD XC Repair & Protect Stainless Steel Fan Housing On Air Handler At Large Wastewater Treatment Facility

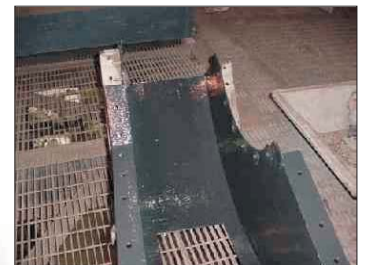
Two coats of CHEMCLAD XC were applied to all interior surfaces and flanges.
