Nevada Gold Mine Selects DuraQuartz & CHEMCLAD to Repair & Protect Chemical Containment Areas

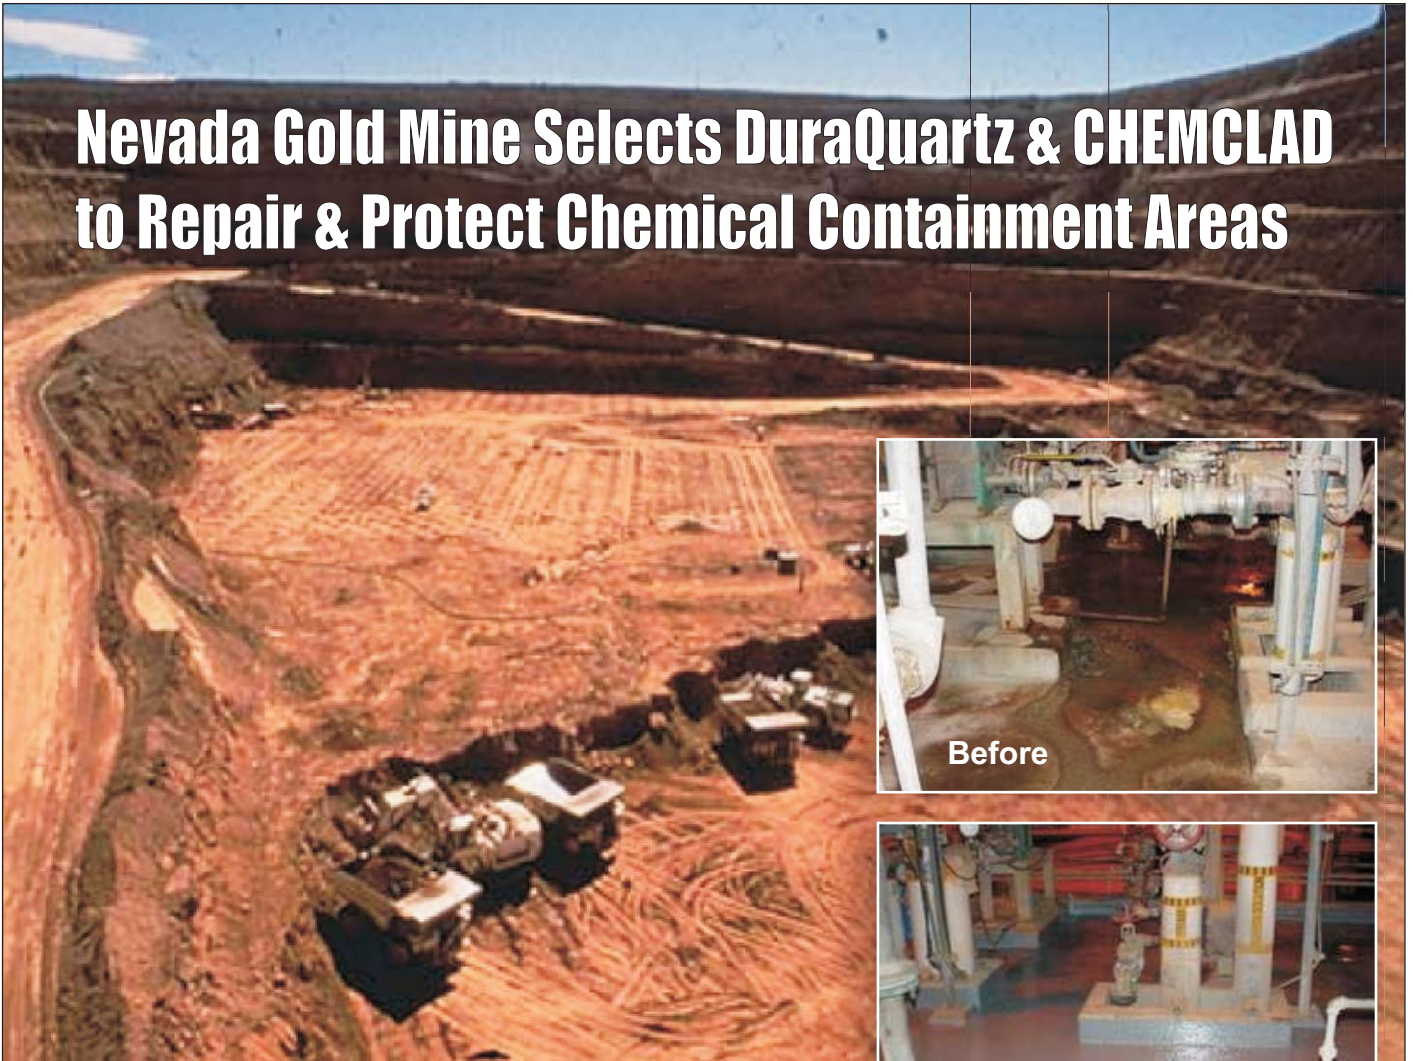
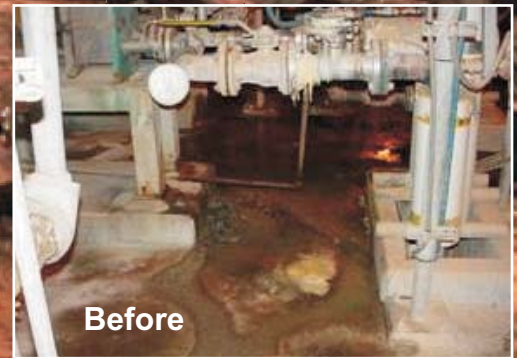
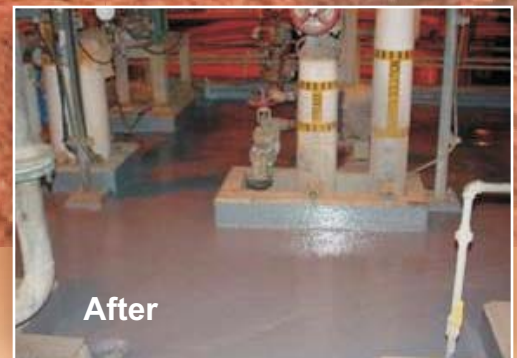
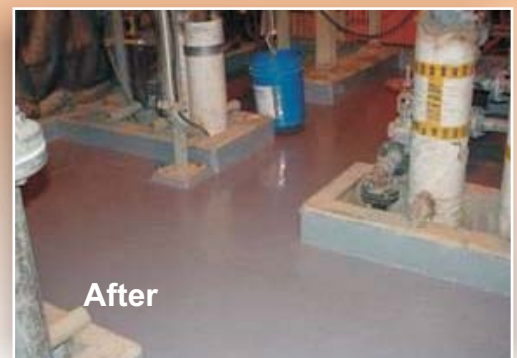
This concrete containment area was severely damaged by the strong chemicals used to strip gold from carbon ore. The chemical attack problems were exacerbated because the floor was pitched away from drains causing the chemicals to pool in certain areas.

Nevada's Team ENECON was called in to solve the problem. The containment

area was first water blasted to remove all chemical contamination as well as any loose or crumbling concrete. The drainage problems were corrected by using ENECRETE DuraQuartz to pitch the floor toward the drains.

Two coats of CHEMCLAD SC were then applied to prevent future chemical attack problems.
