## ENECRETE DuraQuartz Conquers Critical Concrete Problems

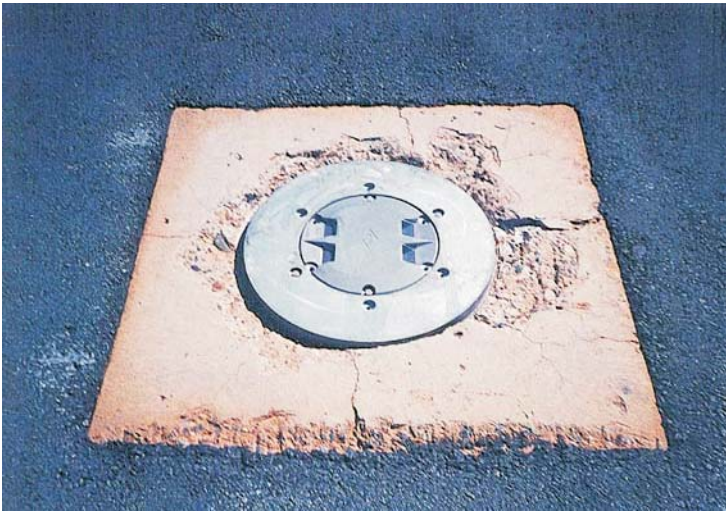
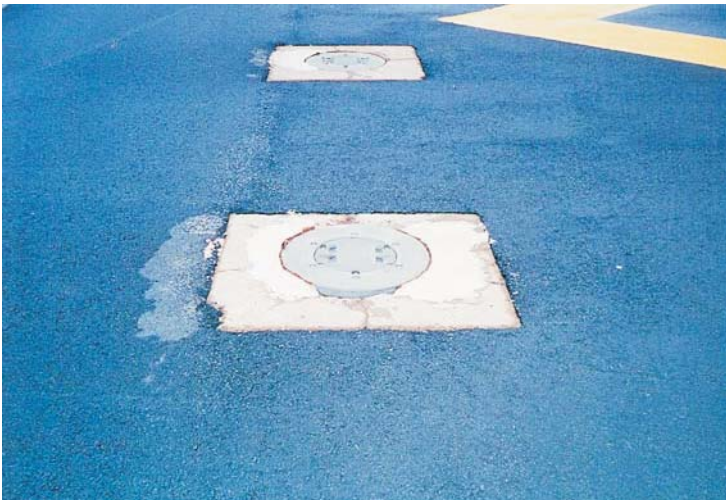
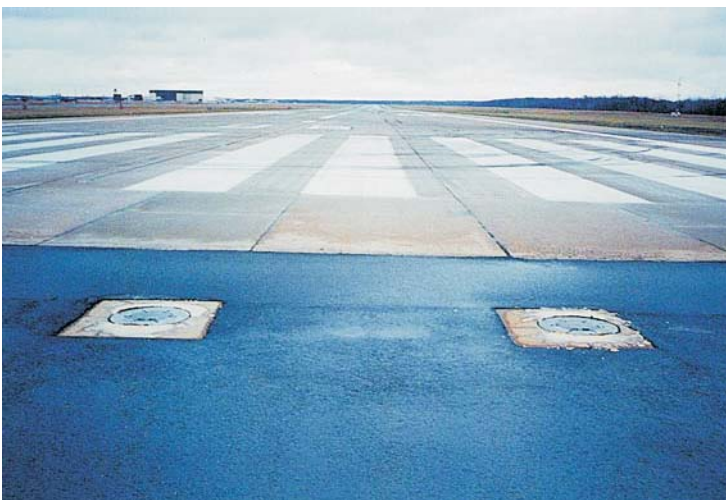
These concrete pads for these airport runway lights were badly deteriorated from service conditions subjecting them to freeze/thaw cycles, de-icing salts and mechanical damage.

Matt proposed an idea he was certain would “fly” with the engineers...the use of **ENECRETE DuraQuartz**. A number of lights had to be repaired; but, the

engineers knew that they would not have time to enable them to carry out all the repairs at once. They were, therefore, quite pleased that the DuraQuartz could be mixed in unit quantities to allow for the repair of as few - or as many - light pads as time allowed.

In addition, the fact that the DuraQuartz would bond to the concrete, as well as the light's metal holder/housing mounted in the concrete, proved additionally beneficial.
