The access gates of this underground pipe chase had become a safety concern for the facility's engineers.

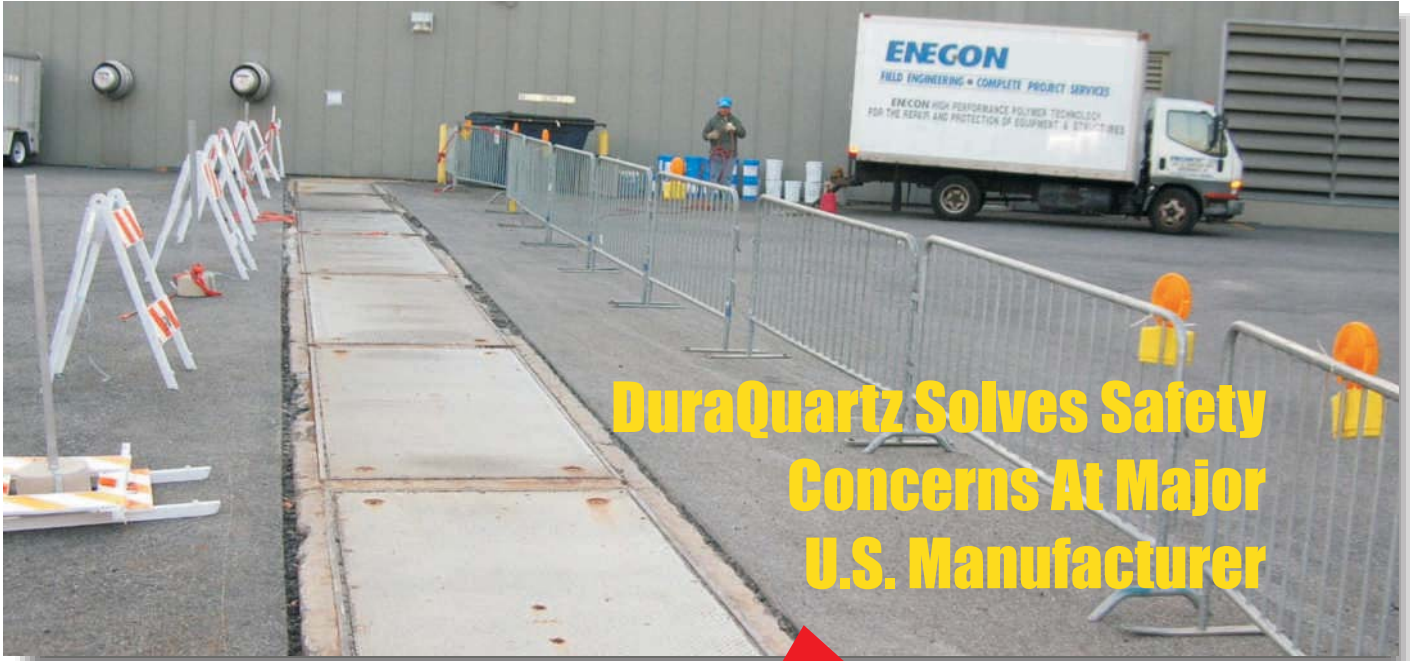
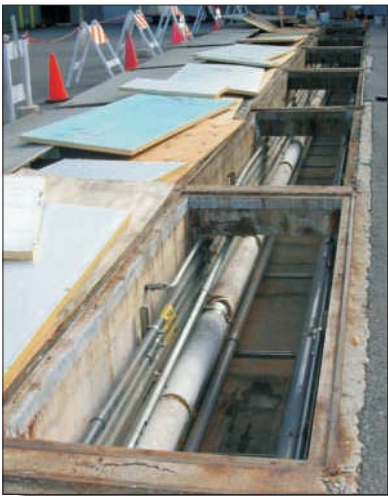
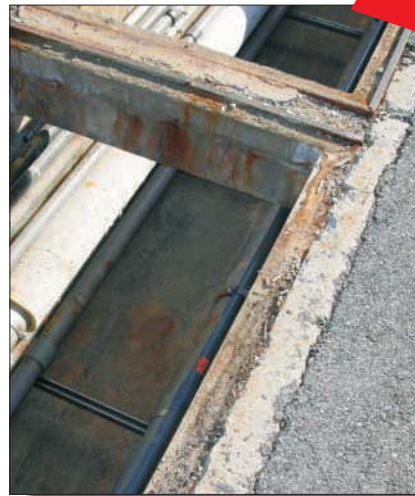
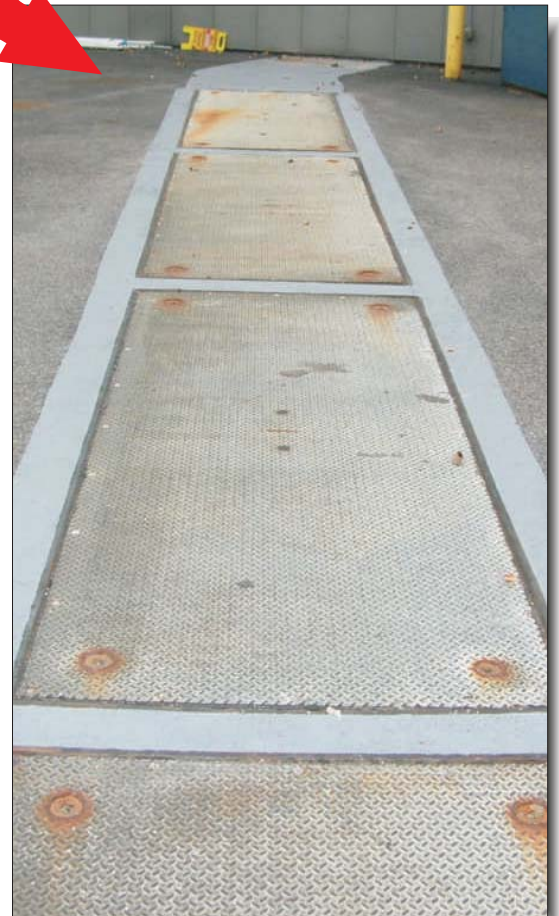
This high traffic area, subject to countless freeze/thaw cycles, had been repaired many times with conventional water-based cementitious materials with little success. The local ENECON Engineering Specialist was contacted to find a cost effective, fast and safe solution.

It was suggested that all of the loose material in the damaged areas surrounding the access plates be removed and then cleaned.

ENECRETE DuraQuartz was then used to build up and level out the damaged concrete surfaces.

By using the DuraQuartz system, the facility's engineers not only solved the 'safety problem', they were able to do it under budget and on time.
