New Jersey Grout
Manufacturer
Repairs & Protects
Containment Areas
with DuraQuartz,
FPS - 2000 &
CHEMCLAD SC.

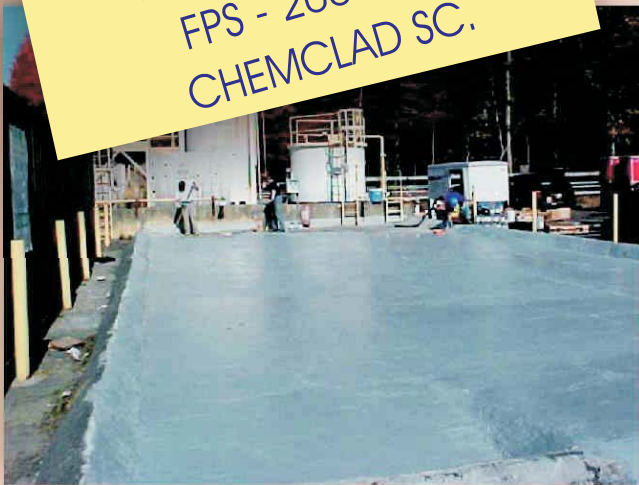
This, the largest of the three areas was first power washed, then abraded with a floor sander; cracks were repaired with ENECRETE DuraQuartz and then coated with ENECLAD FPS 2000.

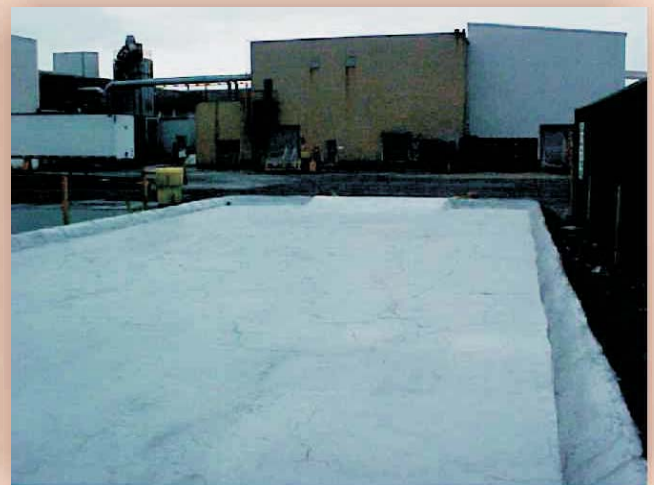
View from the opposite direction. Pallets containing drums of chemicals are stored here.

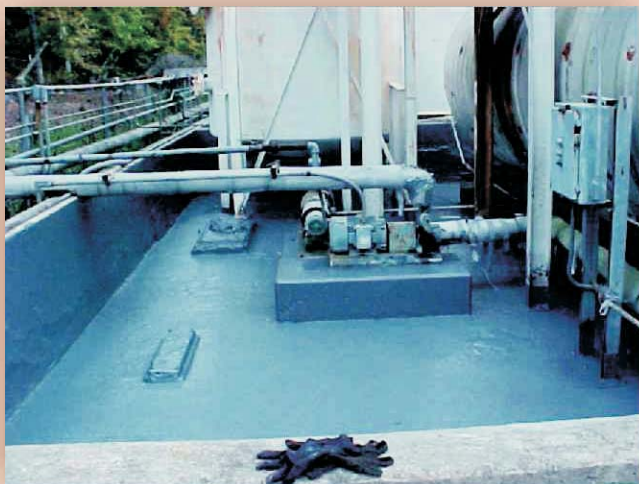
The second containment area was first power washed, cracks were repaired with DuraQuartz, P4C was applied over the concrete followed by 2 coats of CHEMCLAD SC.

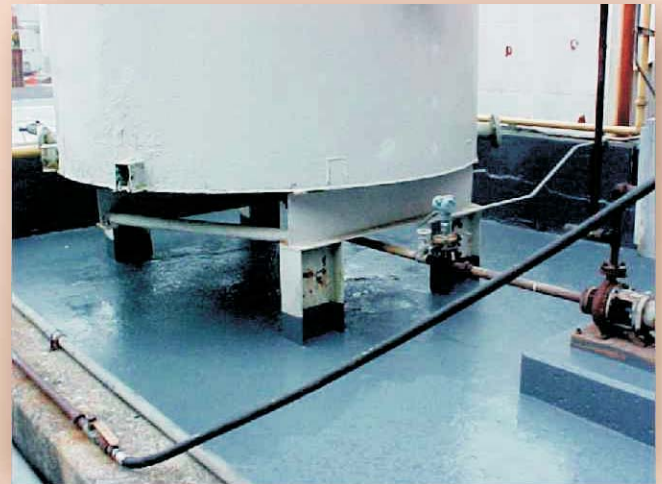
The third containment area was repaired and protected as per the second containment area.
