Nuclear Power Plant in Spain Selects ENESEAL HR to Repair & Protect This Concrete Containment Building Dome

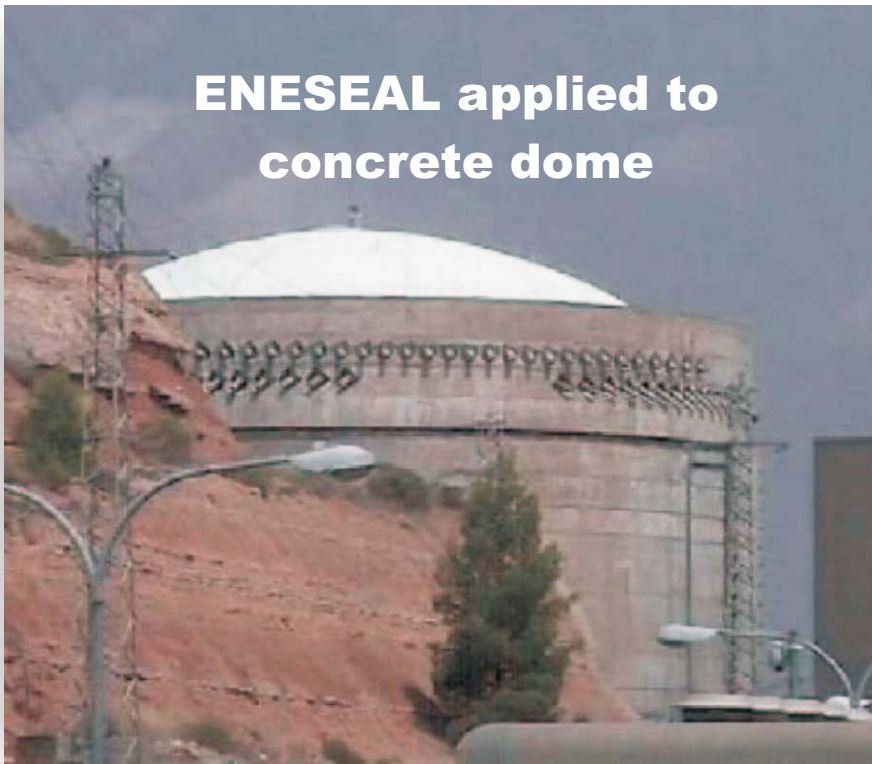
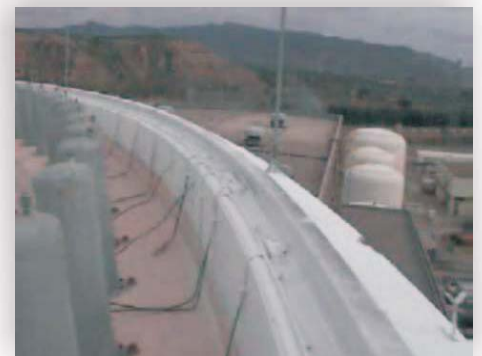
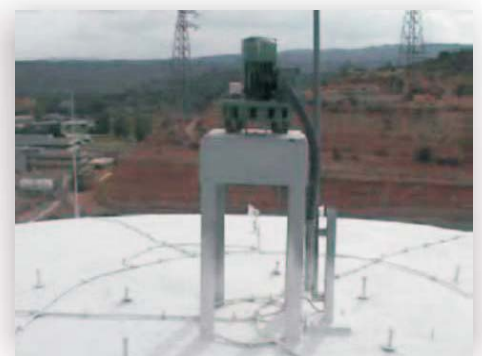
This massive concrete dome was showing signs of severe deterioration. The previously applied protective coating system had failed and hairline cracks were appearing throughout the dome structure. The plant

ENESEAL applied to concrete dome

The dome was thoroughly grit blasted by the ENECON Ibérica (Spain) Engineering Team and then

3 coats of ENESEAL HR were applied to completely encapsulate the dome, weatherproofing it and also providing a heat refractive shield to the concrete surfaces from the hot Mediterranean sun.
