## Large Polish Warehouse Roof Sealed And Protected With ENESEAL HR

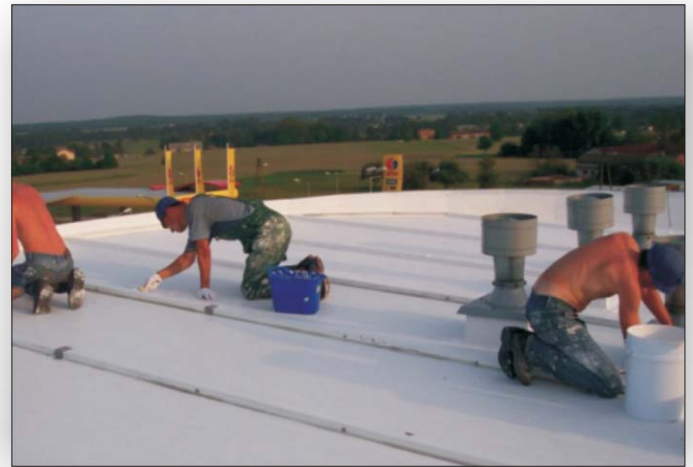
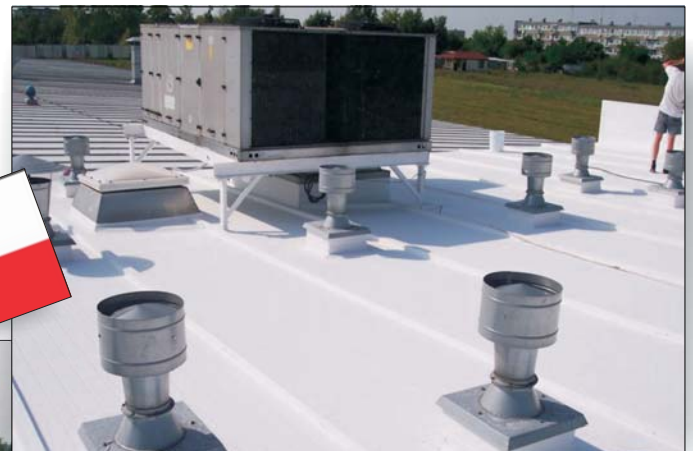
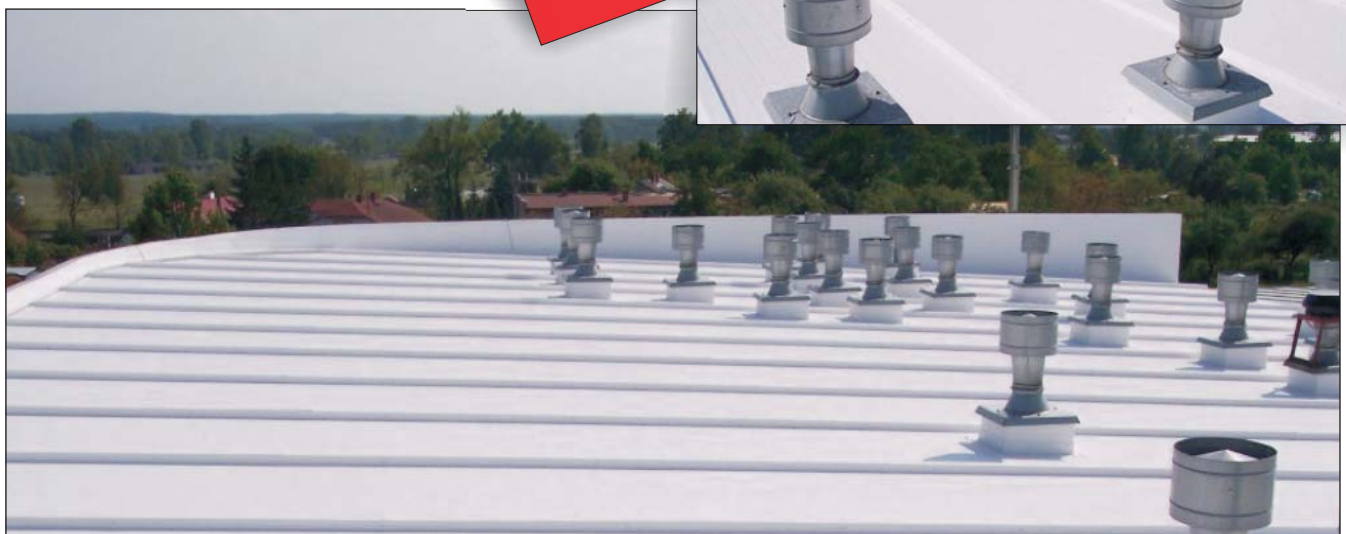
cleaned the entire roof surface which included an alcohol rinse where needed. All joints and seams were first primed with ENECLAD SuperBond in order to insure the best bond possible in these critical areas. Two coats of ENESEAL HR were then applied over the entire roof area.

The 'first class' results speak for themselves.
