Canadian Department of Defense Selects ENECON to Supply Materials For Some of Their Toughest Repairs. Here's One Example...

This field engineering report was filed by an ENECON Fluid Flow Systems Specialist in Canada concerning a very critical repair application on a Naval Destroyer that clearly emphasized our technical competence in

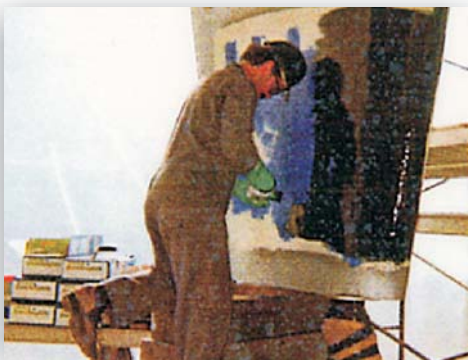
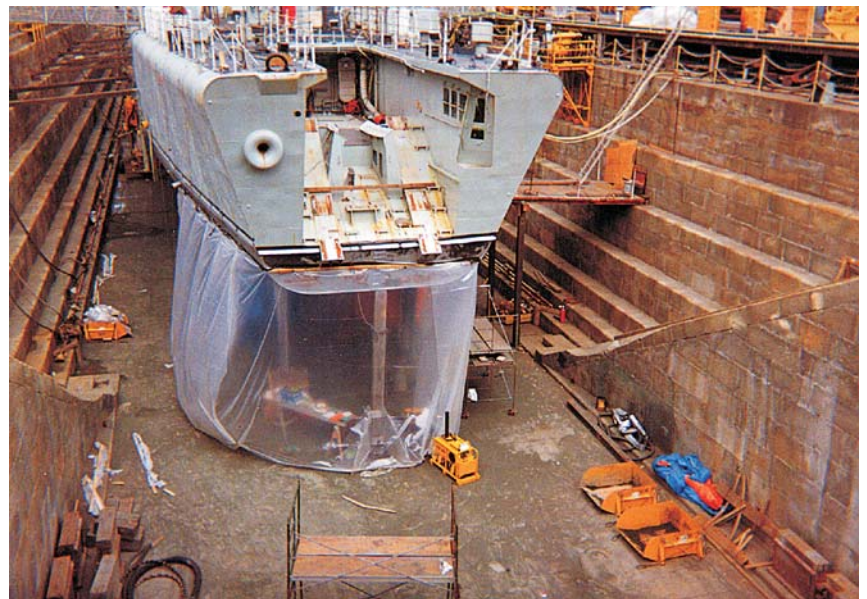
The rudders as well as the A-frames were badly cavitated in localized areas.

DuraTough DP was used to fill the worst of the pitted areas. This was followed by two coats of DuraTough DL.

Care was taken to insure a smooth surface. The DuraTough DP was carefully smoothed out after it had set up for about 15

minutes. The same with the first coat of DuraTough DL.

With a little care and time, DuraTough can be applied to achieve a very smooth surface.
