ENECON Reclaims Severely Damaged Ball Valve for Kuwait's Ministry of Electricity and Water

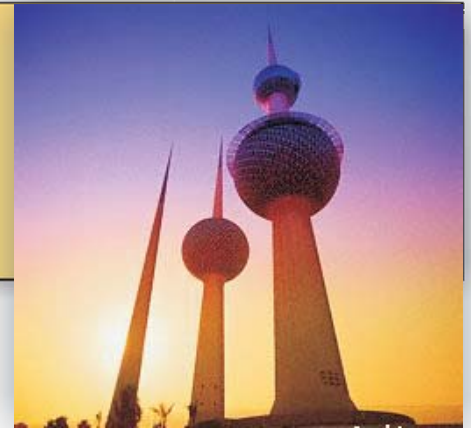
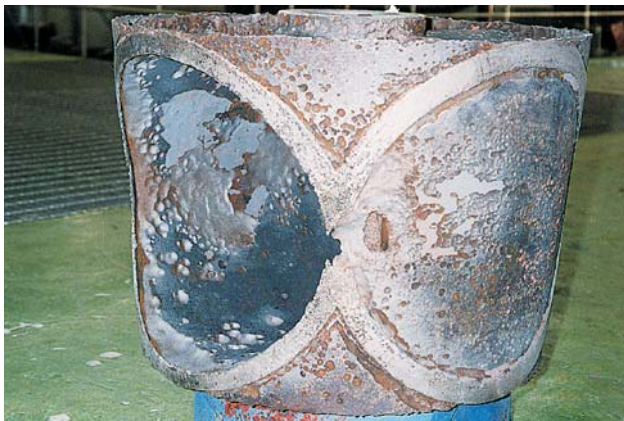
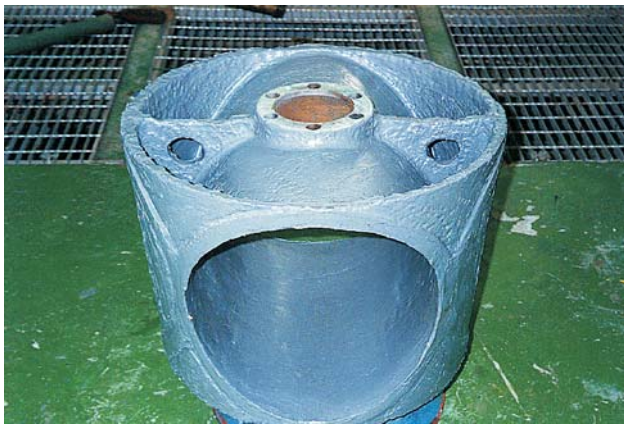
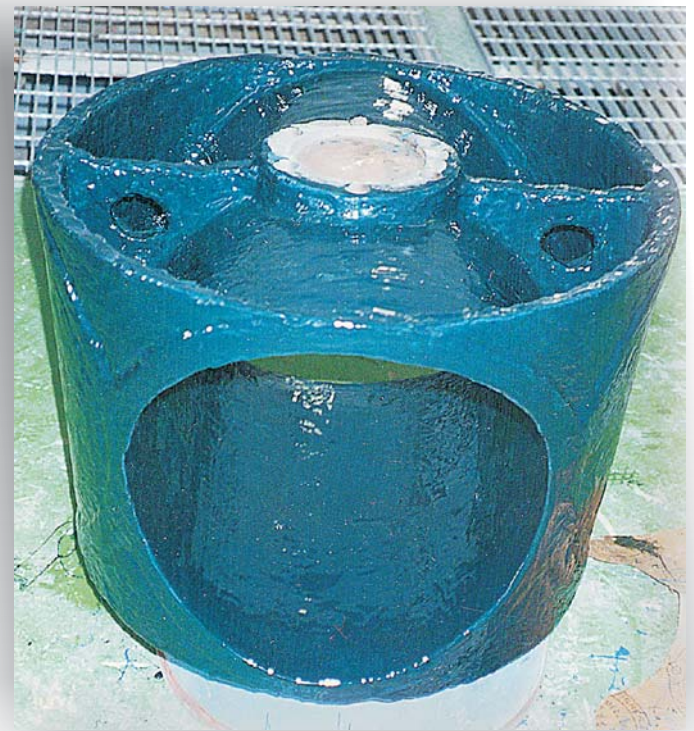
Both the ball and casing of this large valve were severely damaged from aggressive service conditions.

The deeply pitted components were grit blasted and first rebuilt to their original shapes with

CeramAlloy CP+. All surfaces were then completely protected with DuraTough DL - readying the valve for many additional years of service.
