## ENECON Poland Completes Two Propellor Cavitation Protection Projects With FLEXICLAD DuraTough

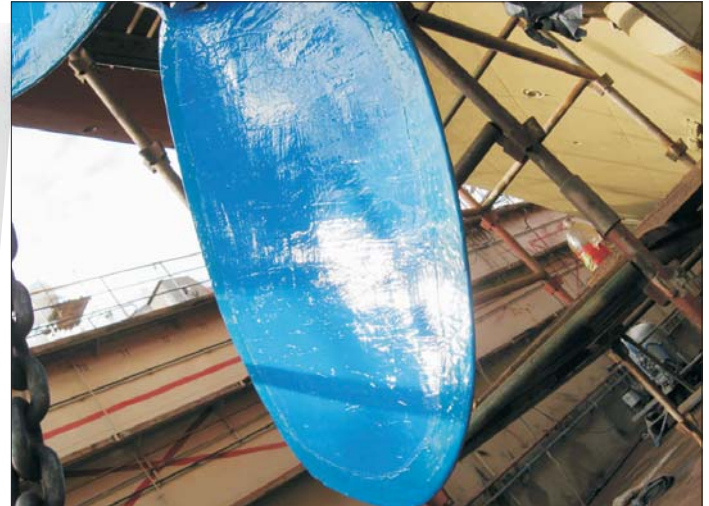
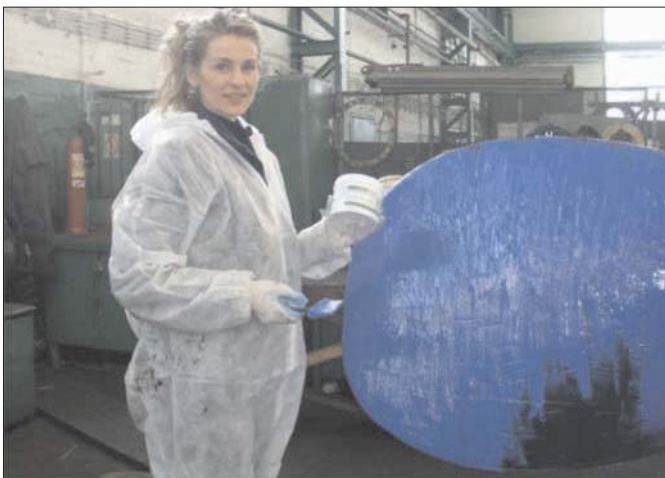
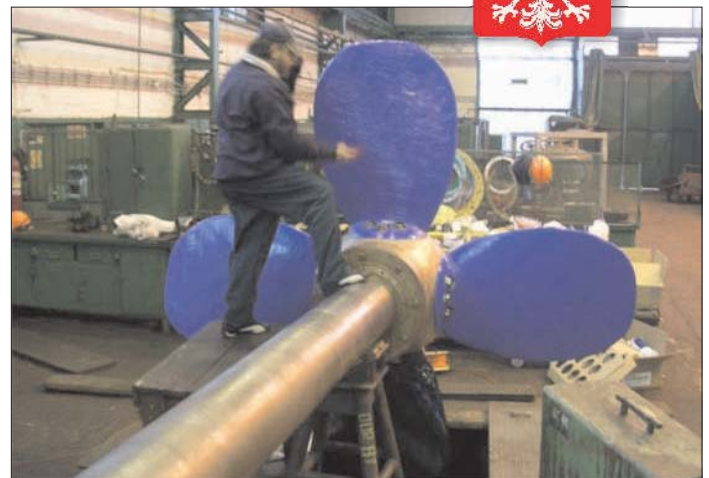
The propellers on these two Norwegian ships were damaged by cavitation attack and needed to be repaired. Both ships were dry docked in Gdynia, Poland.

After thoroughly grit-blasting the propellers, ENECON Poland recommended that any cavitated areas first be repaired with *DurAlloy*,

which was later sanded smooth.

*DuraTough Primer* was then applied over the propeller blades followed by two coats of *DuraTough DL*. Finally, a 'stripe-coat' of CeramAlloy CL+AC was applied over any potential leading edges of the

*DuraTough* to protect them from possible lifting in service.
