Rudder Pintle Housing Repair with DurAlloy Eliminates Expensive Machining Operation

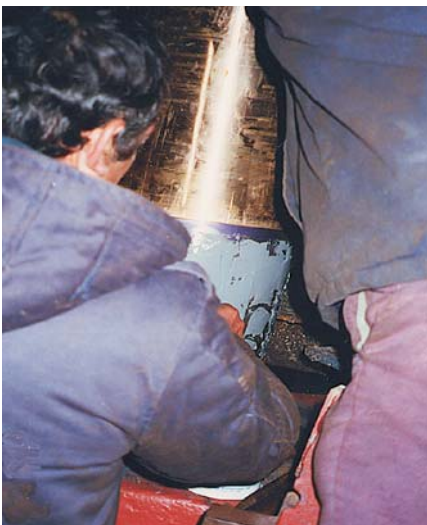
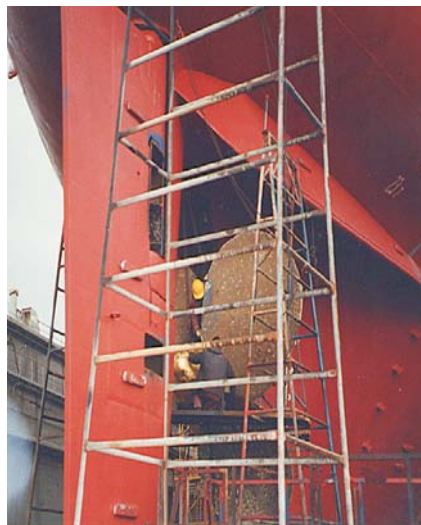
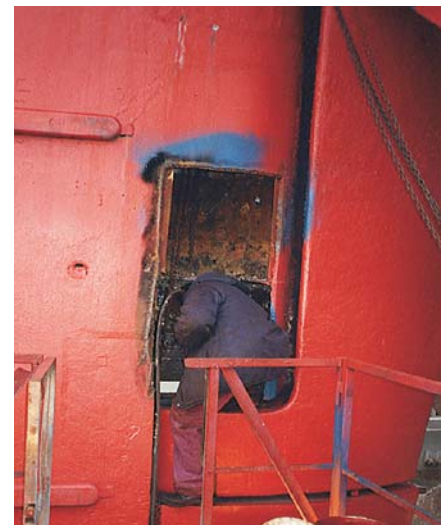
During a dry-docking, the rudder pintle housing on the ship Galia Carmel was found to be severely corroded from the salt water. The normal repair procedure of welding and line boring of this tapered housing would have necessitated numerous man hours as well as the cost of expensive in-place machining equipment.

using ENECON DurAlloy to rebuild the housing. And, by using the pintle to form the housing to the desired dimensions, the need for a subsequent machining operation would be eliminated!

After surface preparation, the DurAlloy was applied to both the housing and the pintle (previously coated with Release Agent) and reassembled, rebuilding the housing and protecting the area from further corrosion.

After reviewing and witnessing the application, the repair was accepted by the Lloyd's Surveyor upon completion.
