## \$300,000 Repair Project Completed at Major Northeastern Utility. 40-Year Old Cast Iron Water Boxes & Tube Sheets Repaired & Protected With CeramAlloy.

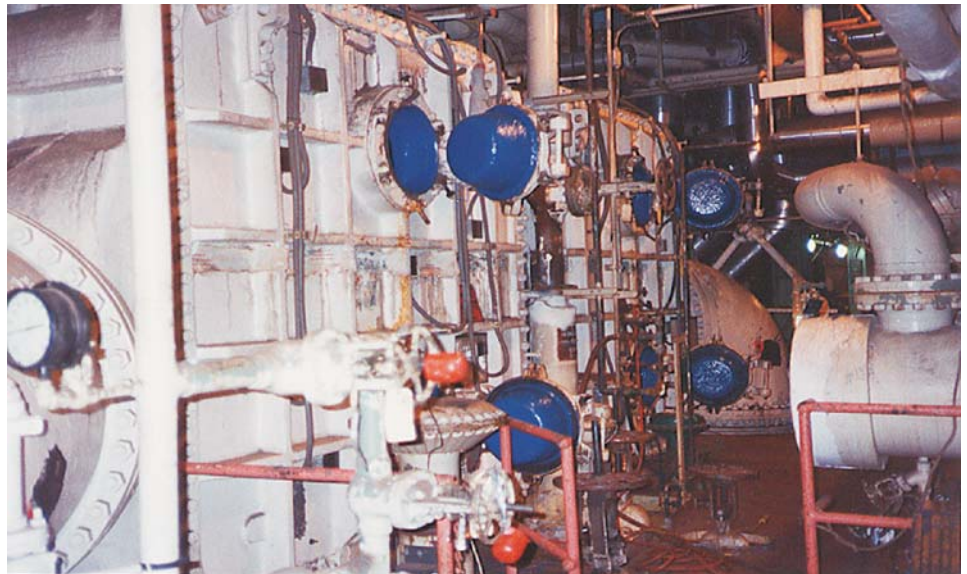
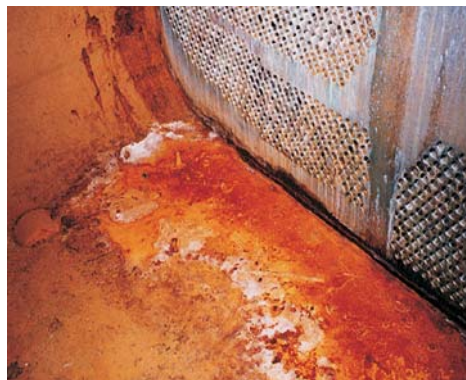
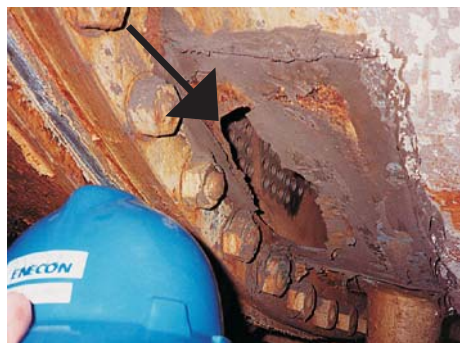
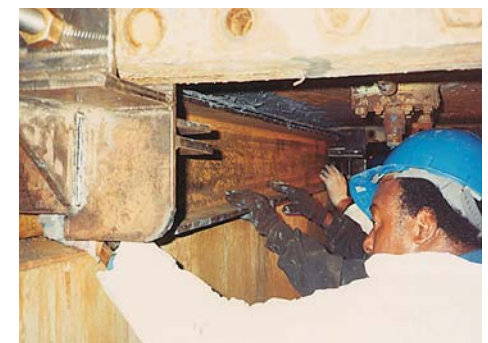
The cast iron water boxes were so severely damaged that huge holes, exposed during grit blasting, had to be repaired using steel plates and girders bonded and sealed with CeramAlloy.

A total of 8 cast iron water boxes which were built in the 1950's plus 8 tube sheets were repaired, rebuilt and resurfaced with **ENECON CeramAlloy**
