The Greek Navy Selects CeramAlloy & DurAlloy to Help Solve Some Very Difficult Repair Problems on Their Ships & Submarines

Here are two examples where ENECON's high performance polymer composites coupled with professional field engineering support have saved the Greek Navy thousands of dollars over conventional repair or replacement procedures.

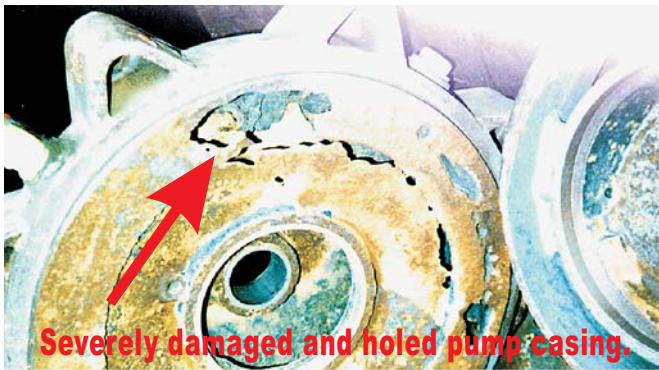
These fire pumps were completely destroyed by erosion and corrosion. METALCLAD CeramAlloy was used to rebuild and

resurface the pumps so that they can provide many more years of service to the Greek Navy.

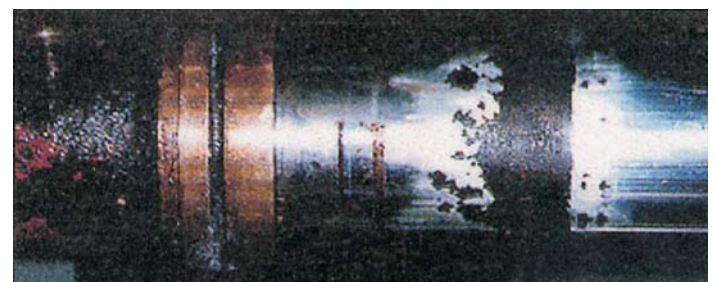
The second example highlights a repair to a damaged periscope piston from a Navy submarine. METALCLAD DurAlloy was used to rebuild the damaged areas saving the Navy a great deal of time and money when compared to conventional welding

or flame spraying repairs.

Of course, since DurAlloy requires **NO HEAT**, the danger of

warping the piston or creating metallurgical damage associated with welding was eliminated.
