## The Greek Navy Selects CeramAlloy & DurAlloy to Help Solve Some Very Difficult Repair Problems on Their Ships & Submarines

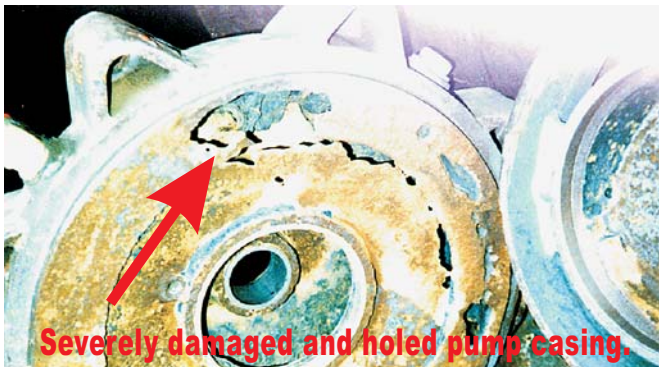
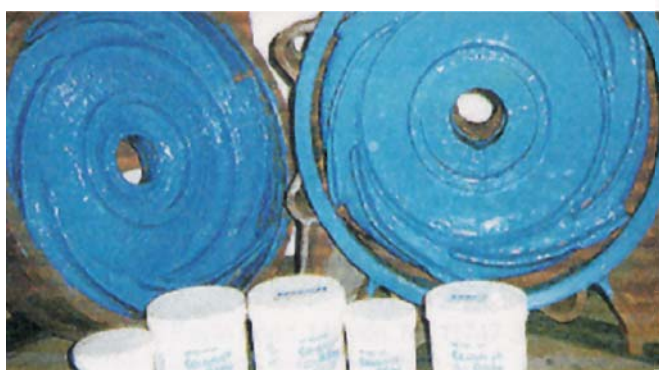
These fire pumps were completely destroyed by erosion and corrosion. METALCLAD CeramAlloy was used to rebuild and

resurface the pumps so that they can provide many more years of service to the Greek Navy.

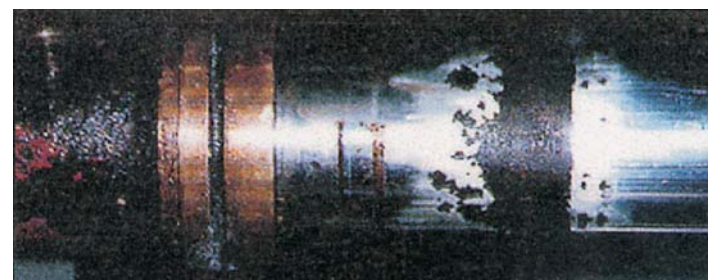
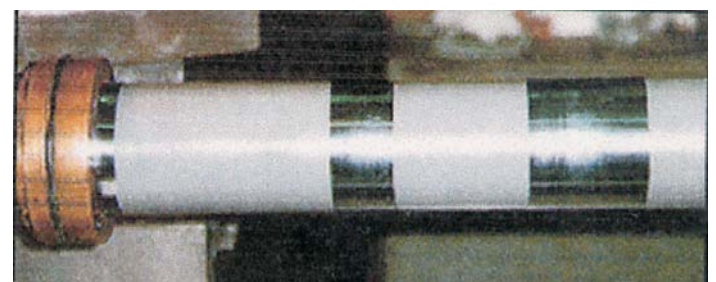
The second example highlights a repair to a damaged periscope piston from a Navy submarine. METALCLAD DurAlloy was used to rebuild the damaged areas saving the Navy a great deal of time and money when compared to conventional welding

or flame spraying repairs.

Of course, since DurAlloy requires **NO HEAT**, the danger of

warping the piston or creating metallurgical damage associated with welding was eliminated.
