CeramAlloy Wrapping Procedure Protects Marine Tail Shafting -- Outperforms Traditional Systems Such as Fiberglass & Conventional Epoxies

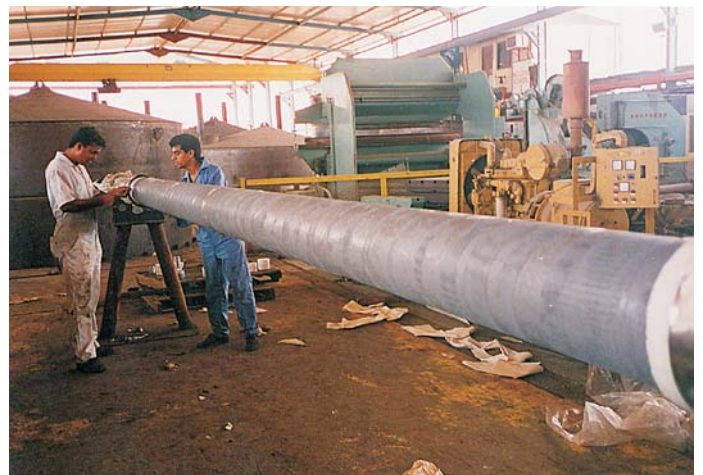
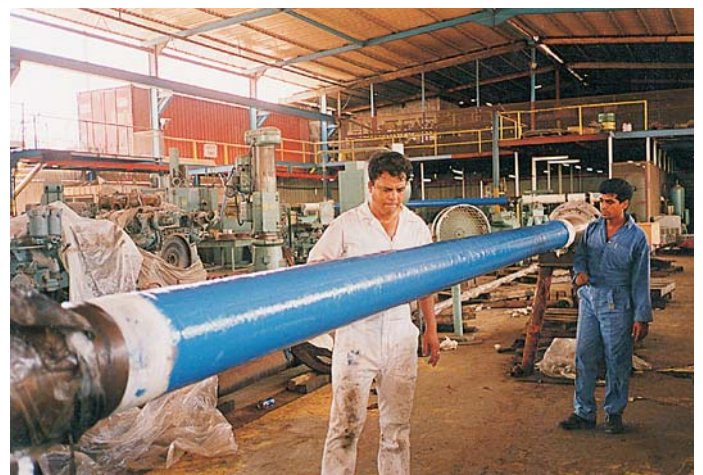
After the shaft was grit blasted, CeramAlloy CP+ was used to fill-in and repair all pitted areas on the shaft.

Then 2 layers of CL+ liquid ceramic were installed utilizing ENECON reinforcing sheet as a wrap between coats of the CeramAlloy CL+.
