## CeramAlloy Wrapping Procedure Protects Marine Tail Shafting -- Outperforms Traditional Systems Such as Fiberglass & Conventional Epoxies

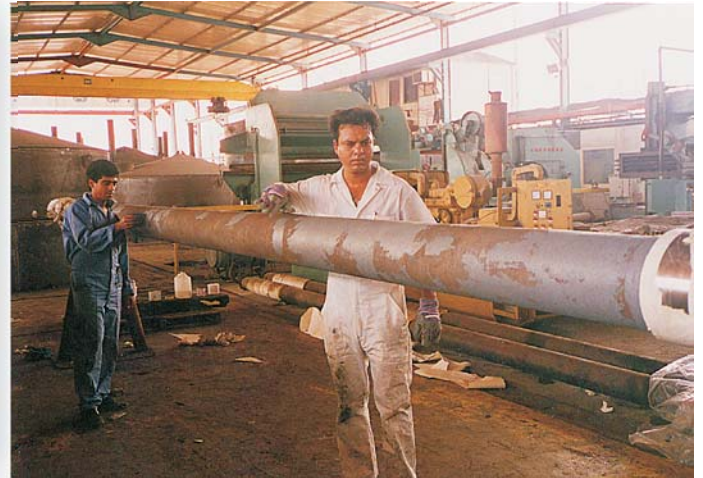
This application at a local shipping company illustrates the effectiveness of CeramAlloy used to repair and then protect

exposed marine tail shafting.
