## ENECON Italia Saves 90-Year Old Pump For The Italian Navy

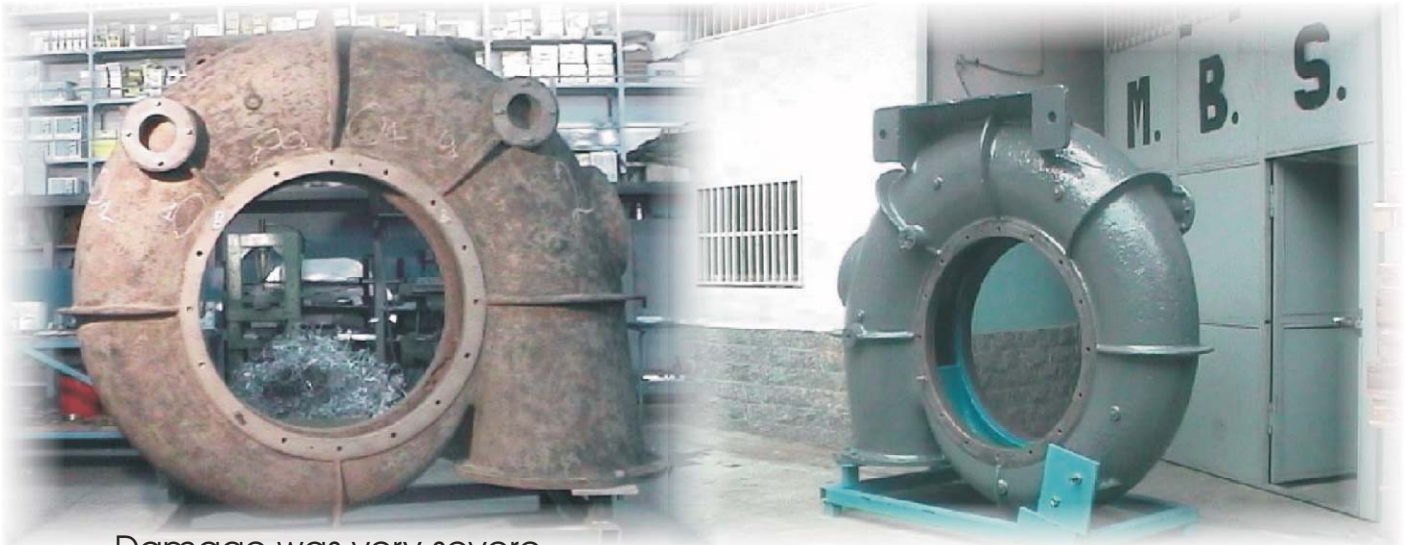
Damage was very severe

This huge, 90-year old, cast iron pump casing and impeller from an Italian Navy dry-dock were so severely eroded and corroded that the facilities engineers had decided to scrap it and order a new pump. The \$100,000 price tag for a new pump, however, persuaded the engineers to have the components rebuilt with ENECON High Performance Polymer Composite materials by the skilled engineering team at ENECON Italia.

The deeply pitted casing was first grit blasted then "primed" with CHEMCLAD SC. The

very deep pits were rebuilt with DuraQuartz and the entire surface coated with two coats of CeramAlloy CL+ [AC]. The outside of the casing was also protected with two coats of CHEMCLAD SC.

The damaged impeller was rebuilt with DurAlloy and then protected from future erosion and corrosion damage with two coats of CeramAlloy CL+ [AC].
