## Power Plant Repairs Manhole Access Covers On Main Cooling Water Intake Lines With CeramAlloy, CHEMCLAD And Some “Imagineering”.

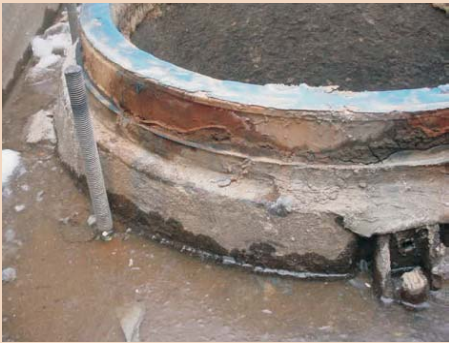
These two concrete manhole covers over the power station's main cooling water intake lines were in very poor condition. It was impossible to keep these sealed. So much water was leaking through the covers that sump pumps had to be used constantly in order to keep the pit from filling up with water.

“The concrete areas where the manhole covers and the pipes meet are in very poor condition.

New steel necks - larger than the O.D. Of the concrete flanges - will be fabricated. The new steel necks will slip over the existing concrete flanges and will be bonded to the concrete using ENECON CeramAlloy CP+AC. The CP+AC will be used to fill in the areas around the neck insuring a complete bond and seal to both the steel and the concrete...

The concrete surfaces will be abrasive blasted to create a suitable anchor profile for bonding. All steel surfaces will be grit-blasted to an SSPC SP-10 (near white metal) finish with a 2-3 mil profile. All prepared metal and concrete surfaces will receive a final two-coat layer of ENECON CHEMCLAD SC...”
