## New York City Wastewater Treatment Plant Turns to ENECON for Critical Pipe Repairs

These photos, supplied by the ENECON North East Engineering Team, illustrate one of many pipe repairs that they carry out regularly throughout New York City.

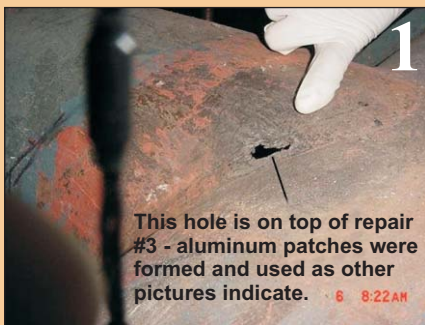
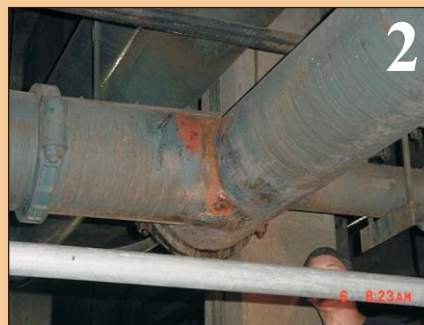
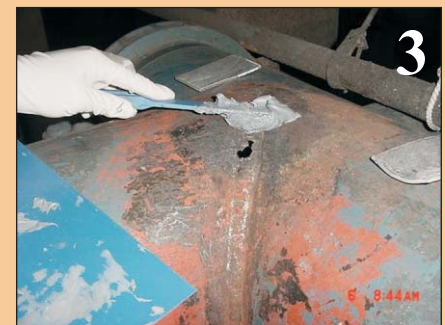
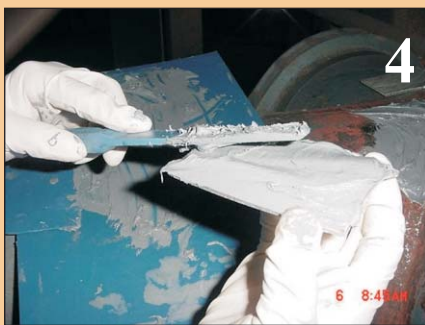
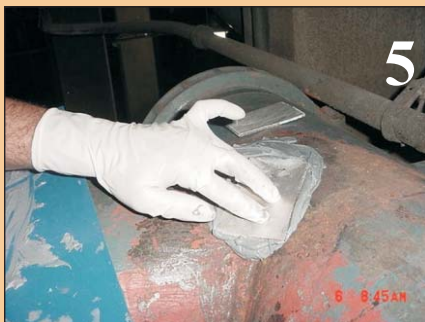
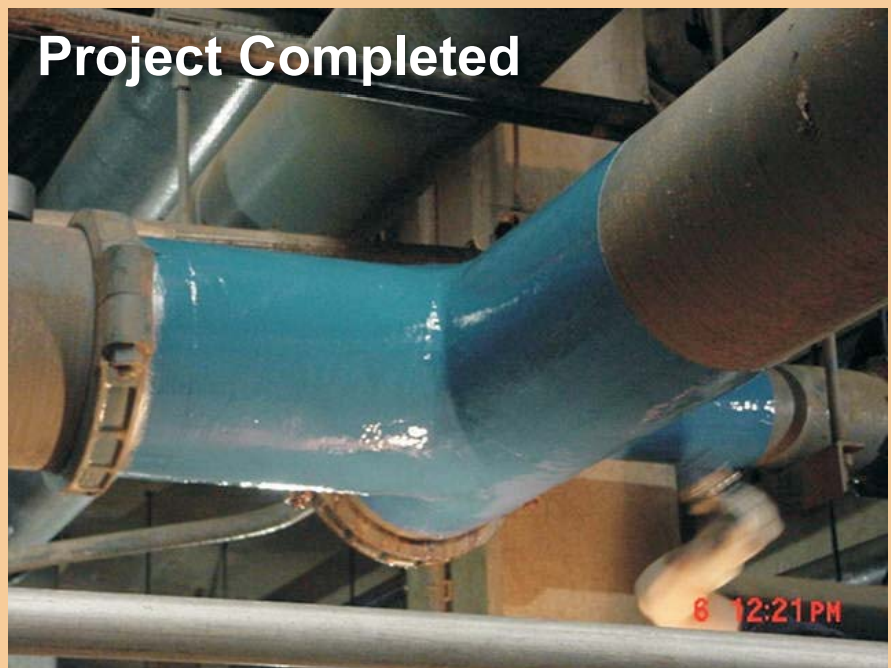
Two coats of CeramAlloy CL + AC were then utilized to complete this pipe-wrap procedure.
