Engineers at a Waste Water Treatment Plant Located in Philadelphia Repair Leaking Pipe Elbow with CeramAlloy

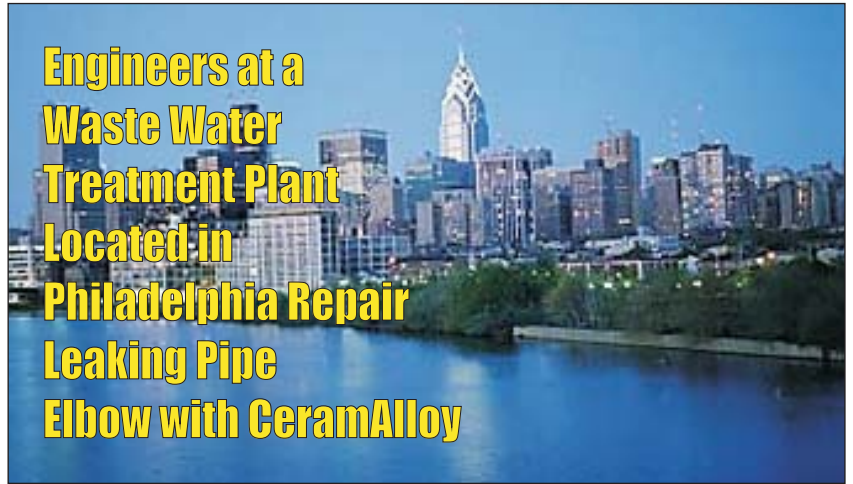
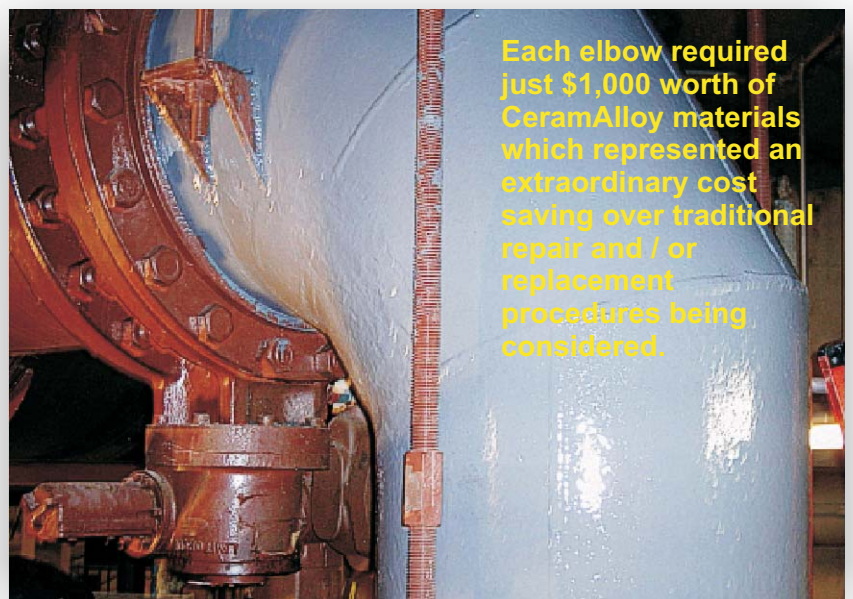
The maintenance engineers at this municipal waste water treatment facility needed a quick as well as cost effective repair on 8 RSP (Return Sludge Pump) exit elbows that had developed leaks. Removal and replacement was an expensive and time-consuming option that would have left the plant vulnerable

to systems overload and possible shut-down.

ENECON engineers suggested an unconventional solution: repair and rebuild the elbows with CeramAlloy CP + AC and CL + AC.

An added cost saving consideration was that all the work could be done by

the plant's own maintenance engineering staff with in-field technical support provided by ENECON's Engineering Team.

Each elbow required just \$1,000 worth of CeramAlloy materials which represented an extraordinary cost saving over traditional repair and / or replacement procedures being considered.
