Military Sealift Command Vessel's Rudder Shafts Repaired & Protected With DurAlloy & CeramAlloy

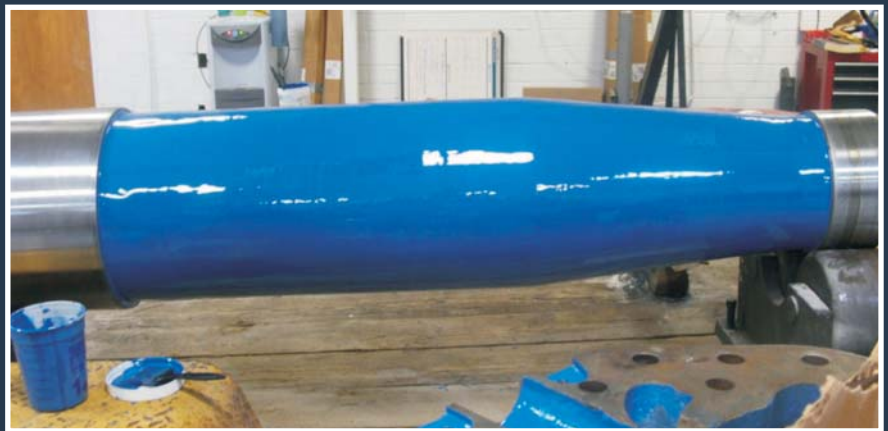
The Military Sealift Command (MSC) needed to effect a cost effective repair on these two rudder shafts from a dredger. They contacted their local ENECON Engineering Team based in South Carolina who recommended using DurAlloy to rebuild the tapered shafts back to original specifications followed by the application of CeramAlloy CL+AC to provide a smooth, wear-resistant surface.

These pictures illustrate the repair procedure as well as the extraordinary final result.
