## U.S. Navy Saves \$37,000 On Emergency Heat Exchanger Repairs

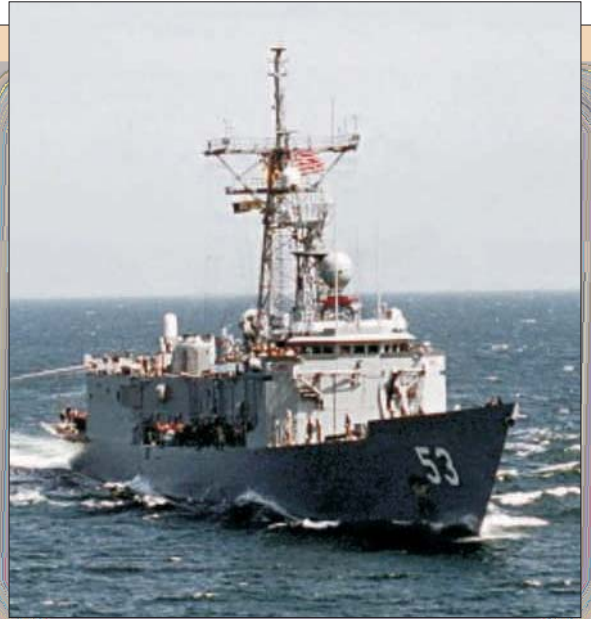
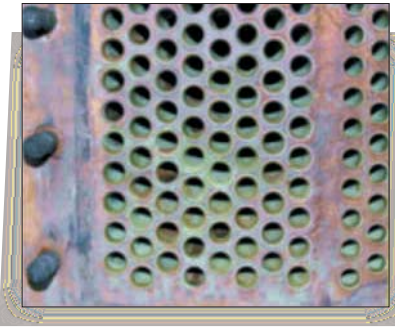
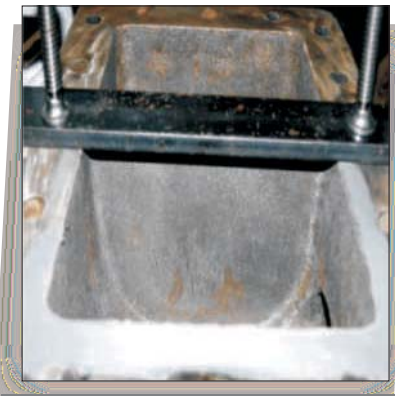
The engineers on this Navy Frigate recently discovered that one of the bleed air heat exchangers was suffering from such severe erosion/corrosion damage that the unit was not cooling sufficiently.

After the unit was grit-blasted, a 3 coat system of CeramAlloy CL+ was applied as illustrated in these photos. This entire project cost the Navy less than \$5,000.
