## DuraWrap Carbon Fiber Pipe Wrap System Saves Tennessee Municipality Thousands of Dollars

Leaky sewage discharge pipe elbow joints, located at a waste water treatment facility in Tennessee, can cost up to \$100,000 and several days of down time to replace after failure.

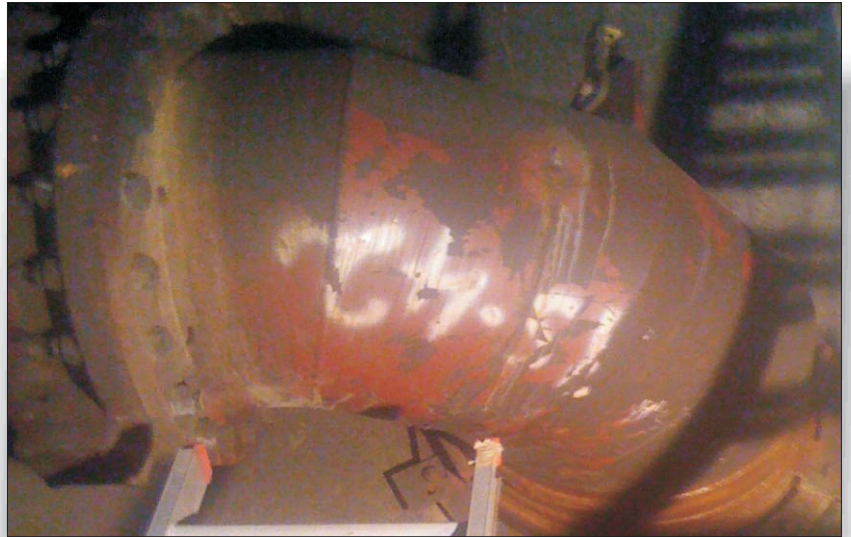
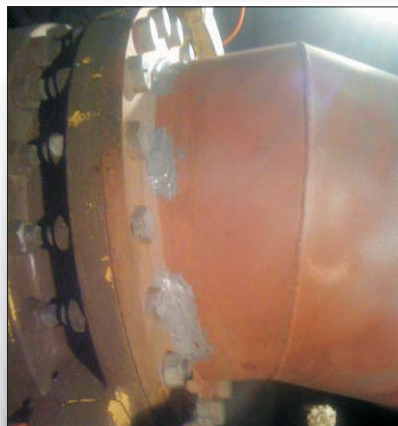
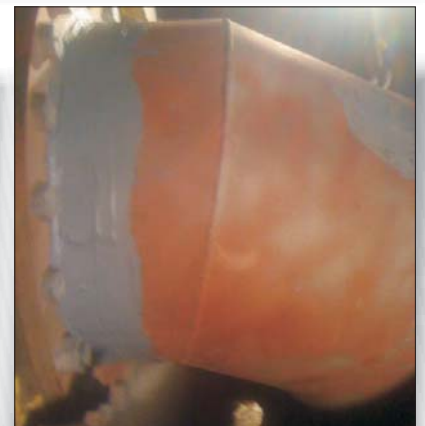
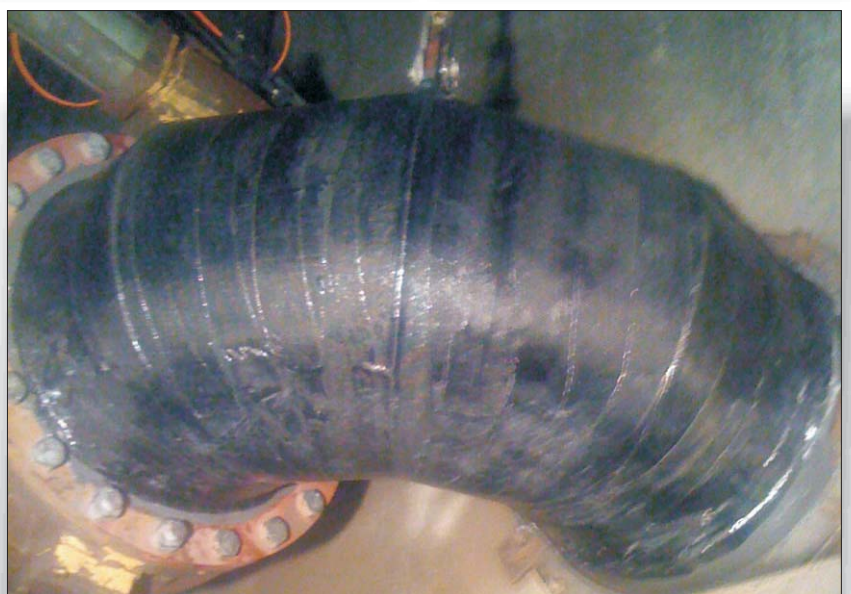
The pipe was first prepared by brush blasting to remove all loose material and corrosion. Any holes in the pipe were sealed with **SpeedAlloy** followed by a reinforcement layer of **DurAlloy**.

After the **DuraWrap** primer was applied, the first coat of polymer saturated carbon fiber was used to wrap the pipe followed by the second layer.

The **DuraWrap** system saved the facility over \$90,000 by **repairing -- not replacing** the aging pipes.
