Canadian Fish Hatchery Uses ENECRETE, ENECLAD & CHEMCLAD To Repair & Protect Trout Pool 10 Years Ago & It Is Still Perfect

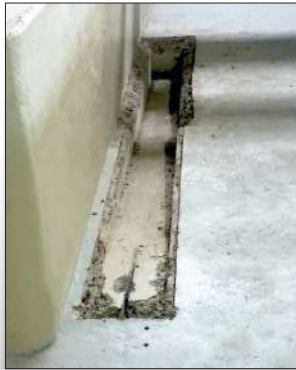
Filter removed

The old filter was cut out of the concrete and a new filter, provided by the hatchery, was set into place using DuraQuartz RR to create a “seat” to ensure a snug fit for the filter. DuraFill with locally sourced aggregate was then used to fill-in the remaining sections of cut-out concrete around the filter.

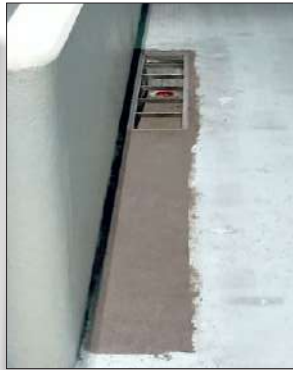
New filter installed

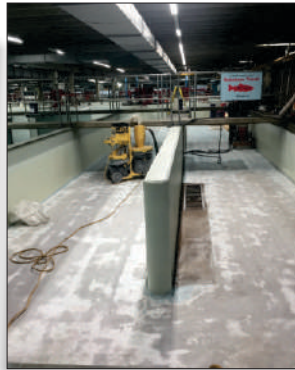
Pool floor prepared

The entire pool floor was then prepared using a floor grinder. ENECLAD CFS was used to prime the floor then two coats of CHEMCLAD SC were then applied.

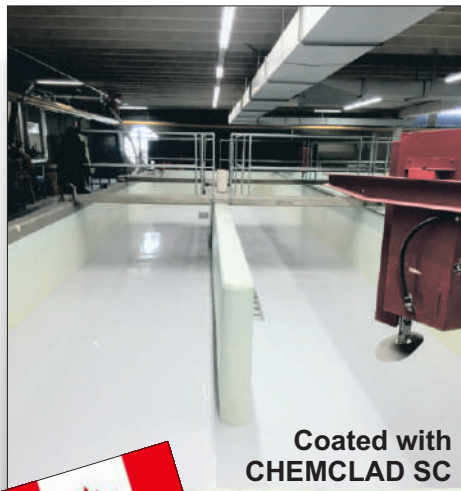
Coated with CHEMCLAD SC

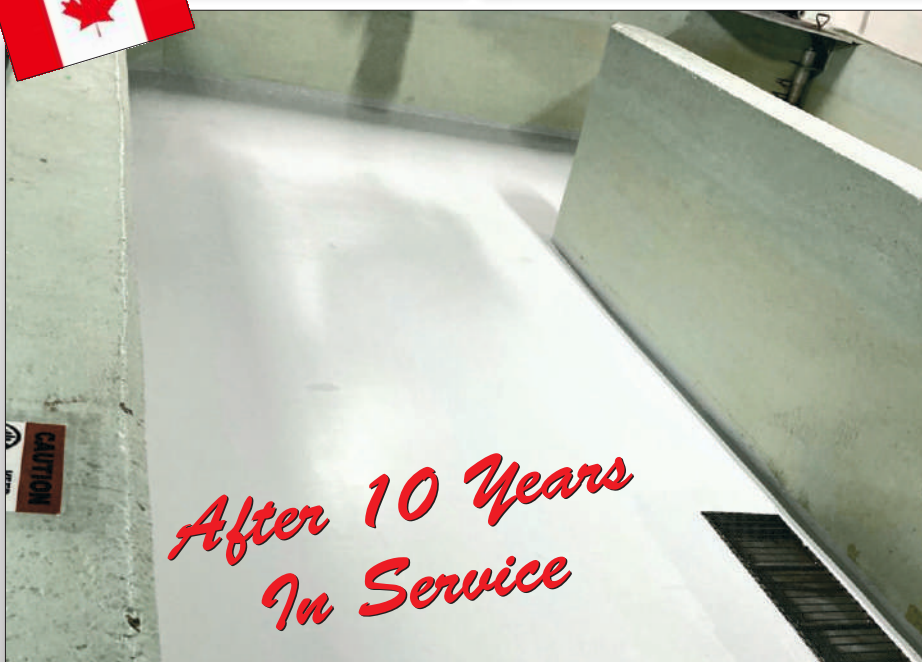
After ten years in service with only minor touch-ups and cleaning, the pool floor is in excellent condition. So much so that the hatchery decided to have the rest (20 more) of their pools protected the same way.

*After 10 Years
In Service*
