Russian Fire Station Floor Repaired With DuraQuartz & Protected With ENECLAD FPS

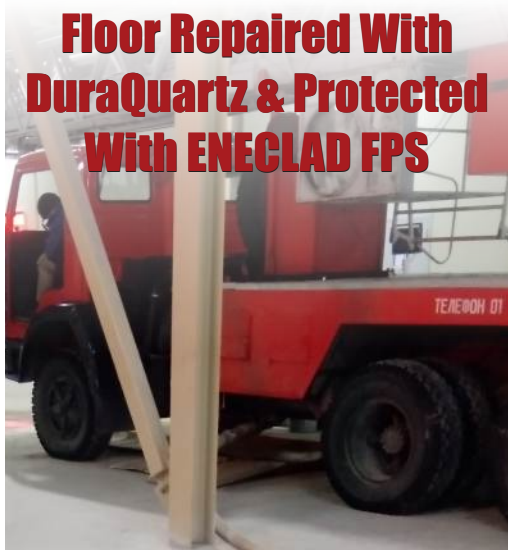
After being constructed and in service only 18 months, the protective coating on the floor of this Russian fire station failed. The concrete was absorbing oil and other liquids. The station operator needed a fast, durable and affordable solution.

First, a floor grinder was used to remove the failed, existing coating. Any necessary repairs to the concrete were made with DuraQuartz, then the entire floor was primed with ENECLAD CFS.

Two coats of ENECLAD FPS in Haze Gray were applied to the entire surface. To complete the intricate striping patterns needed in the fire station, a combination of CHEMCLAD GP in Safety Yellow and CHEMCLAD XC in White and Dark Gray were used.
