## ENECON's DuraWrap Carbon Fiber Pipe Wrap System Repairs & Protects Large Water Treatment Plant Pipes

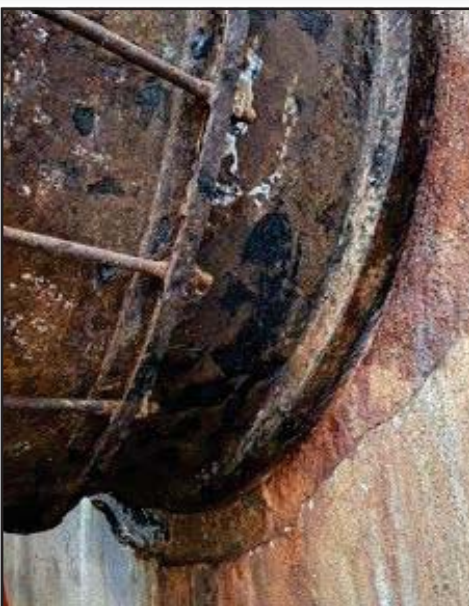
**Before**

Large, underground pipes located at a water treatment plant in the northeastern US were leaking after years in service and gradual corrosion. The plant needed a solution that would not only stop the leaking, but also protect these pipes from future corrosion issues.

white metal profile. Since the pipes remained in service, any active leaks were stopped with METALCLAD SpeedAlloy QS and SpeedAlloy. Any other problem areas with pitting or corrosion damage were repaired with the DuraWrap Primer.

The pipes were first grit blasted to a 3 mil,

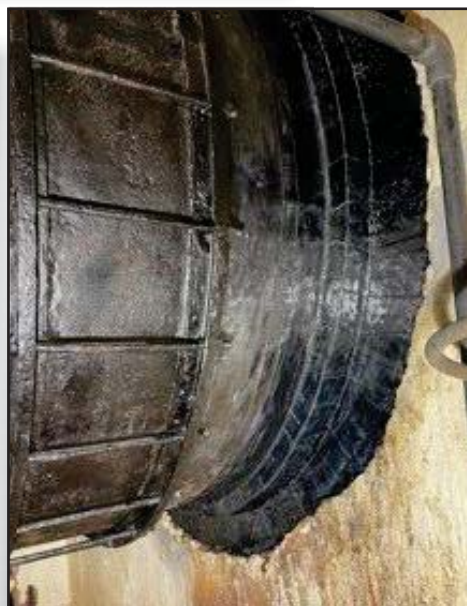
**DuraWrap applied**

The carbon fiber was then applied to the pipes to restore their integrity. A final encapsulation with ENESEAL CR was done to help prevent any surface corrosion on the pipes in the years to come.
