This commuter ferry operating in San Francisco Bay was experiencing an unusual problem. Its twin hull, catamaran design incorporates "tongue and groove" aluminum deck boards to span the area between the hulls. Salt water was coming up through the boards causing accelerated corrosion. In addition, the carpeting in the passenger compartment was constantly wet, resulting in complaints from the commuters and a potentially hazardous condition.

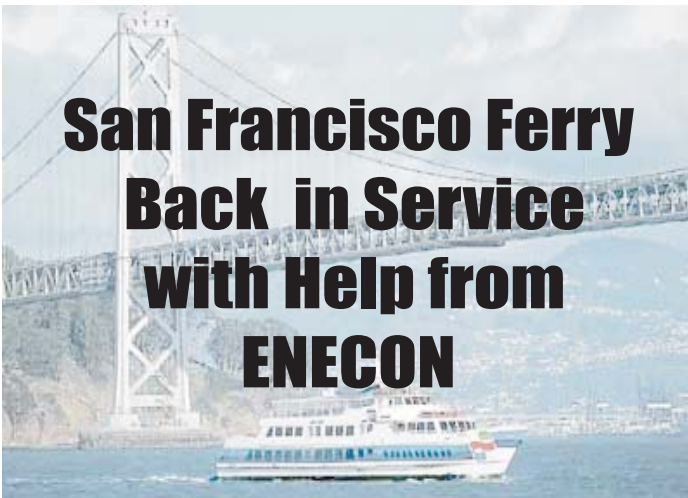
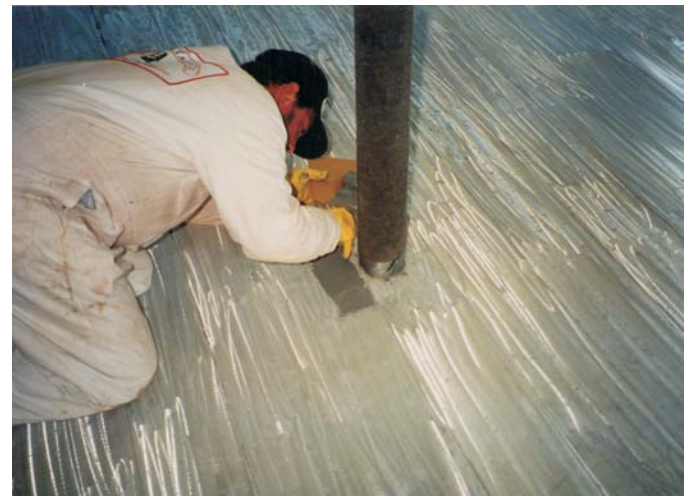
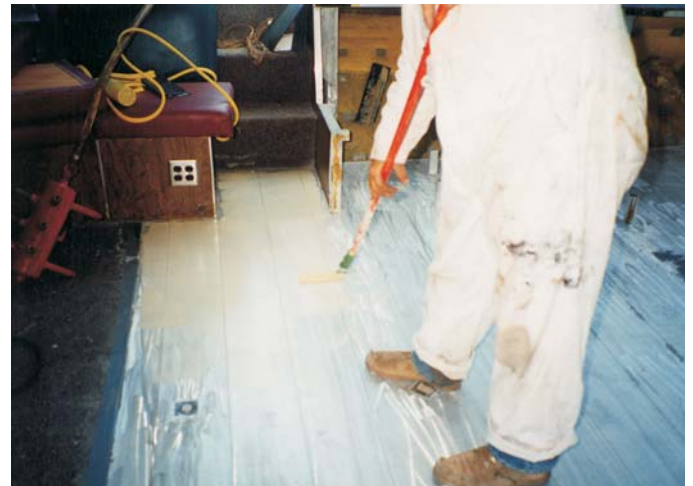
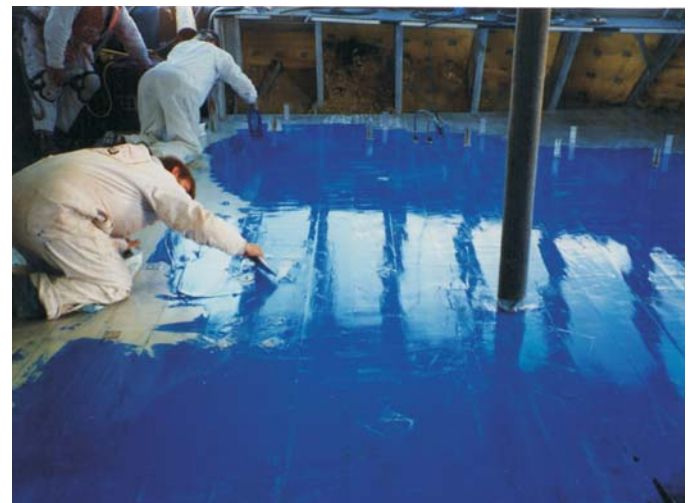
After preparing the surface, a number of badly pitted areas were identified and spot repairs were carried out using METALCLAD DurAlloy. DuraTough was then applied, followed by the application of DuraTough DL to the entire deck area.

After the DuraTough application was completed, new carpeting was installed and the vessel returned to service.
