High Rise Office Building Cooling Towers Repaired with CHEMCLAD SC

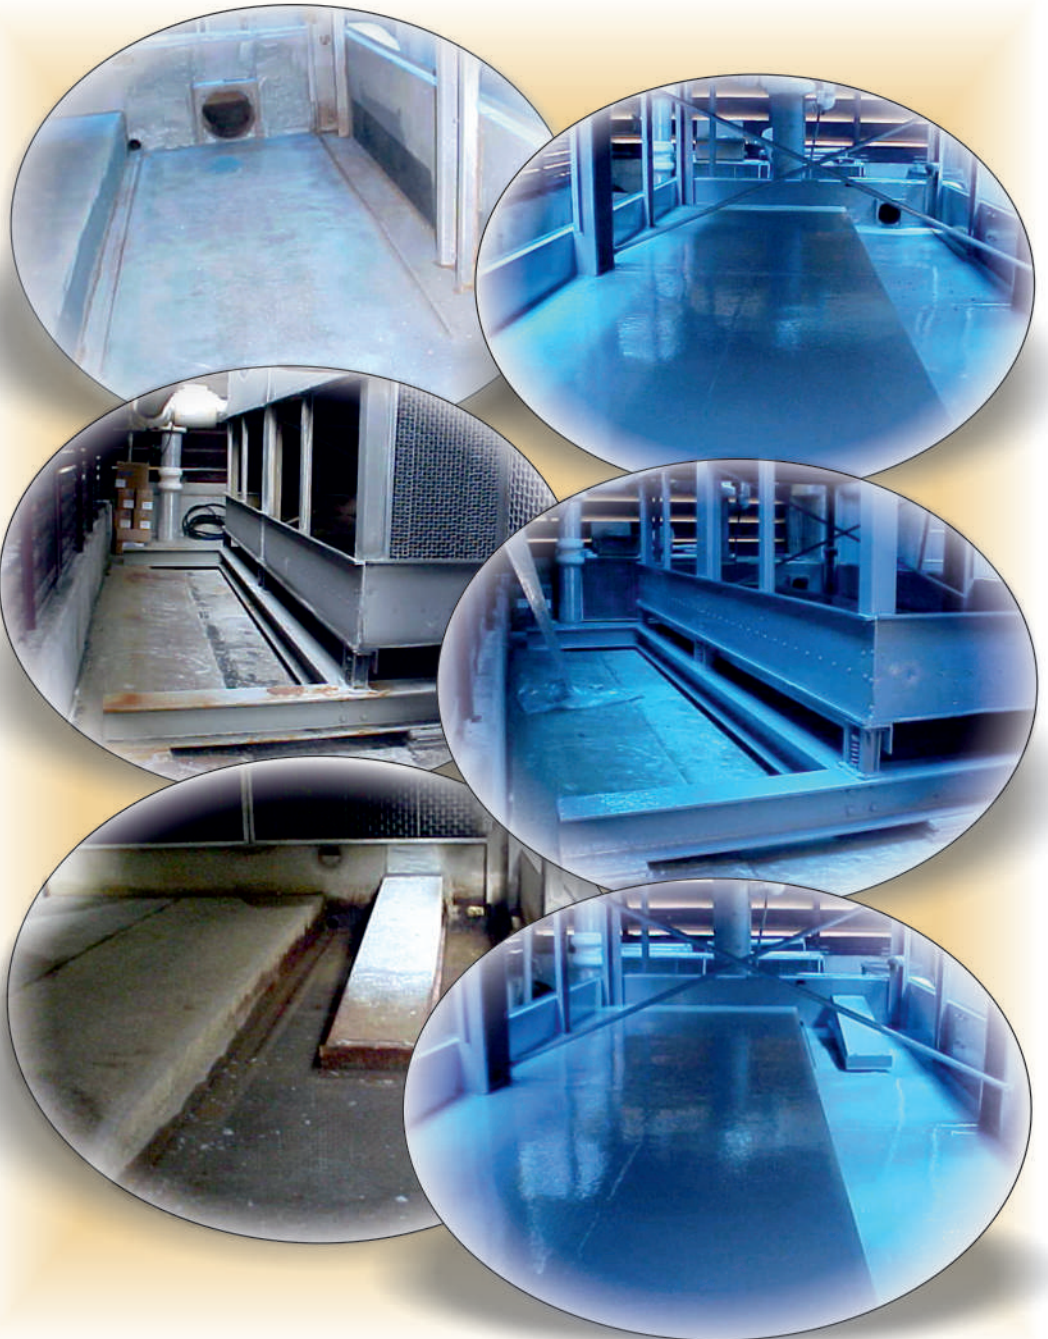
The cooling towers on this high-rise office building located in Jersey City, NJ, were corroded and leaking. The cooling tower pans had large holes that had been plugged with temporary rubber patches. The cooling towers were losing water at an alarming rate.

The building management company turned to Robert Ringhoffer, ENECON's District Manager in Northern New Jersey, for help. Robert recommended using DurAlloy to patch the holes in the pans and then the application of two coats of CHEMCLAD SC to completely resurface the cooling tower pans as well as the steel girders that support the towers.

This extensive repair and reclamation project cost just \$35,000 (a fraction of what it would have cost to replace the pans and support structure); and it was completed in just a few days to the complete satisfaction of the building's facilities manager.
