Italian Coast Guard Selects CHEMCLAD XC To Solve Corrosion Issues

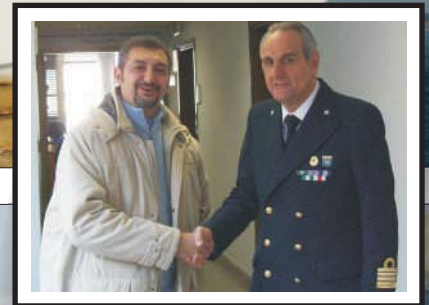
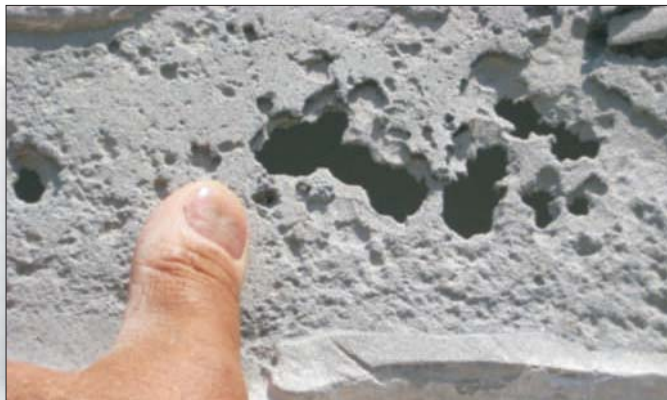
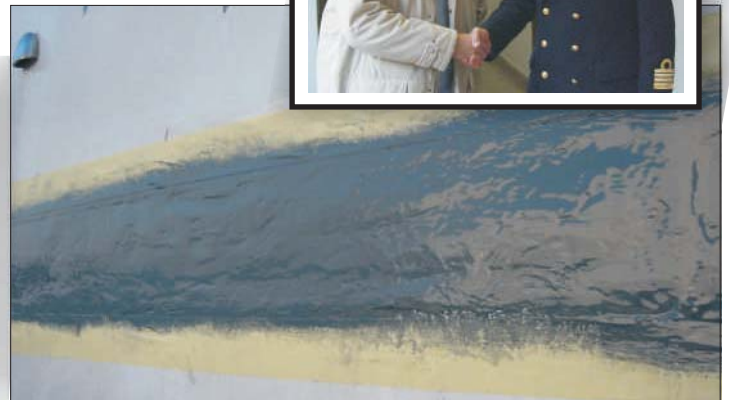
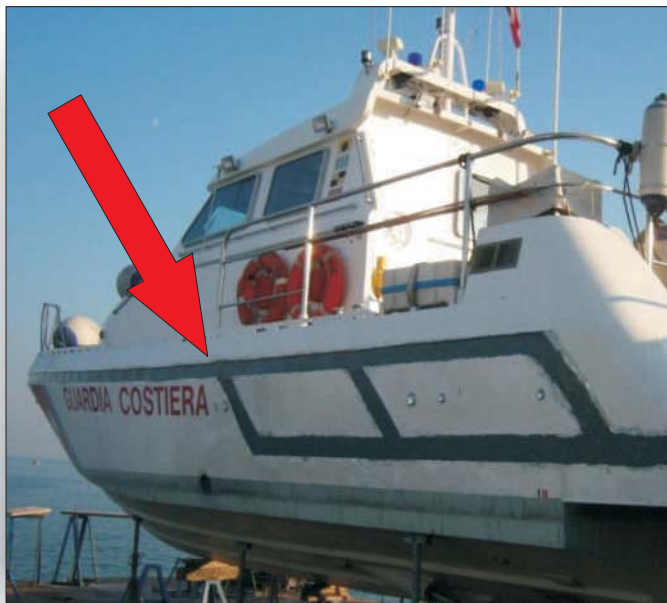
This Italian Coast Guard vessel had been experiencing some severe corrosion on its hull.

The affected area was first grit blasted to remove all corrosion and prior coatings. The entire area was then rebuilt with 6 mm of CeramAlloy CP+AC and reinforcement mesh.

This repaired area was then protected with CHEMCLAD XC.
