METALCLAD & CHEMCLAD Fight Corrosion on Northern California Wastewater Treatment Facility Vacuum Truck Tank

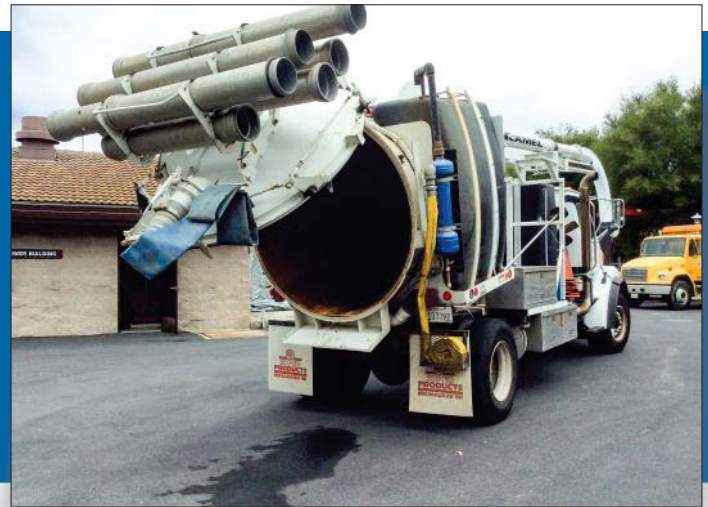
After years of use, this Northern California wastewater treatment facility vacuum truck was suffering from extreme corrosion.

The tank's surface was prepared by high pressure washing and grit blasting being careful to properly protect the vital inner hydraulic components.

Severely pitted areas were rebuilt with CeramAlloy CP+AC. Followed by 2 coats of CHEMCLAD SC to provide optimal chemical protection.
